EASTMAN PERFORMANCE FILMS, LLC

AIRBLAST LOADING TEST REPORT

ASTM F1642/GSA TS01 TESTING ON *DR15 SR PS9* SAFETY AND SECURITY PERFORMANCE FILM
INSTALLED ON A FIXED WINDOW SYSTEM
(SINGLE PANE, TEMPERED, SILICONE GLAZING ATTACHMENT)

J3983.02-119-12 R0

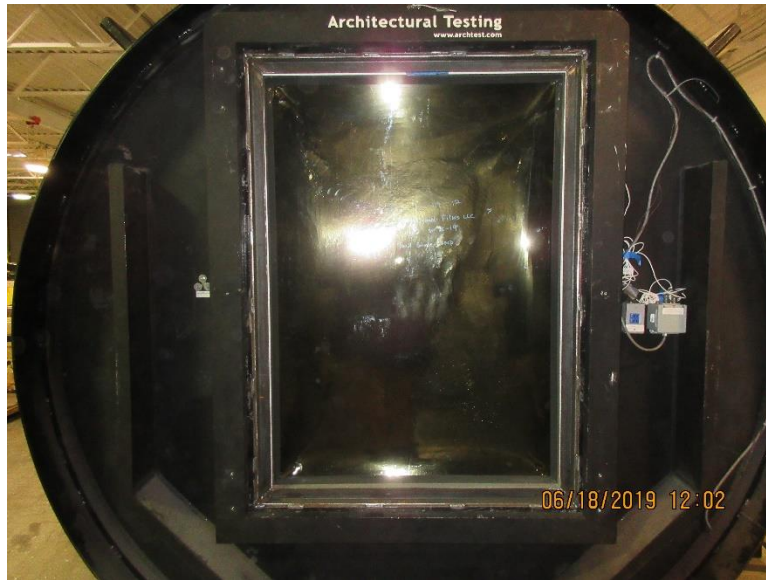
Photo No. 2
Post-test Specimen #1, Interior

DESCRIPTION	RESULTS
Ambient Temperature	80°F
Glazing Temperature	82°F
ASTM Hazard Rating	No Hazard
GSA Performance Condition	2
PEAK POSITIVE PRESSURE	
Top Pressure	6.28 psi
Right Pressure	6.45 psi
Shell Pressure	6.25 psi
Average Pressure	6.33 psi
Witness Chamber Pressure	0.34 psi
PEAK POSITIVE PHASE DURATION	
Top Duration	12.17 msec
Right Duration	12.88 msec
Shell Duration	13.14 msec
Average Duration	12.73 msec
PEAK POSITIVE PHASE IMPULSE	
Top Impulse	41 psi*msec
Right Impulse	41 psi*msec
Shell Impulse	40 psi*msec
Average Impulse	41 psi*msec
GLAZING RESPONSE	
Exterior Lite	Fractured
Interior Lite	N/A
Glazing Pullout	None
Film Tearing	None
WITNESS CHAMBER RESULTS	
Glazing cracked but remained fully retained. No damage observed to the witness panel.

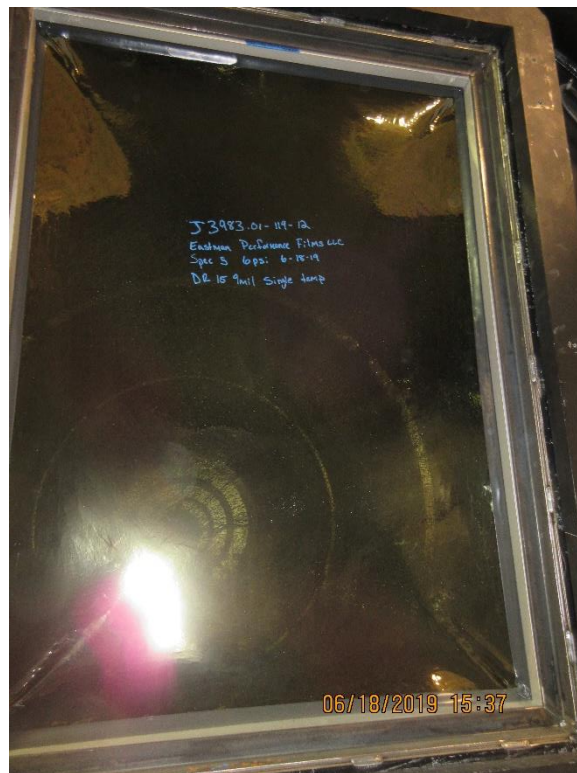
Photo No. 5
Post-test Specimen #2, Interior

DESCRIPTION	RESULTS
Ambient Temperature	83°F
Glazing Temperature	85°F
ASTM Hazard Rating	No Hazard
GSA Performance Condition	2
PEAK POSITIVE PRESSURE	
Top Pressure	6.31 psi
Right Pressure	6.14 psi
Shell Pressure	6.06 psi
Average Pressure	6.17 psi
Witness Chamber Pressure	0.28 psi
PEAK POSITIVE PHASE DURATION	
Top Duration	12.60 msec
Right Duration	11.83 msec
Shell Duration	12.41 msec
Average Duration	12.28 msec
PEAK POSITIVE PHASE IMPULSE	
Top Impulse	40 psi*msec
Right Impulse	40 psi*msec
Shell Impulse	41 psi*msec
Average Impulse	40 psi*msec
GLAZING RESPONSE	
Exterior Lite	Fractured
Interior Lite	N/A
Glazing Pullout	None
Film Tearing	None
WITNESS CHAMBER RESULTS	
Glazing cracked but remained fully retained. No damage observed to the witness panel.

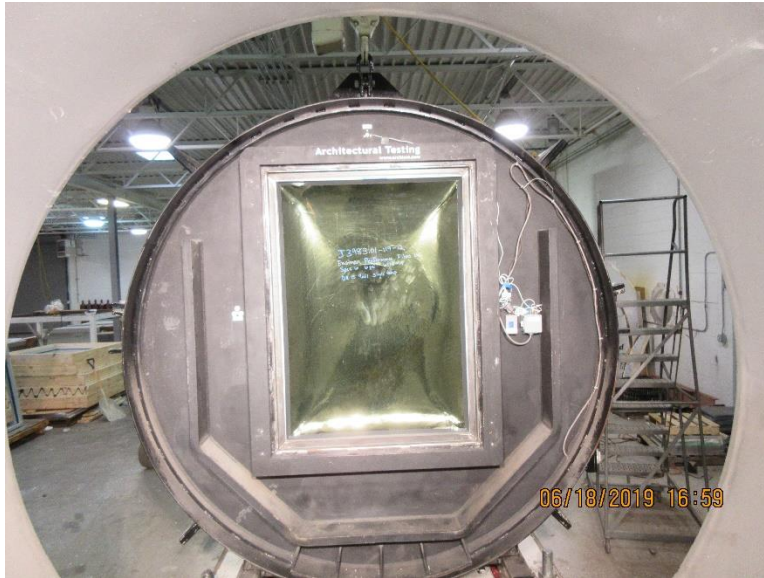
Photo No. 8
Post-test Specimen #3, Interior

DESCRIPTION	RESULTS
Ambient Temperature	84°F
Glazing Temperature	86°F
ASTM Hazard Rating	No Hazard
GSA Performance Condition	2
PEAK POSITIVE PRESSURE	
Top Pressure	6.21 psi
Right Pressure	6.45 psi
Shell Pressure	6.03 psi
Average Pressure	6.23 psi
Witness Chamber Pressure	0.39 psi
PEAK POSITIVE PHASE DURATION	
Top Duration	10.53 msec
Right Duration	11.83 msec
Shell Duration	12.18 msec
Average Duration	11.51 msec
PEAK POSITIVE PHASE IMPULSE	
Top Impulse	43 psi*msec
Right Impulse	43 psi*msec
Shell Impulse	42 psi*msec
Average Impulse	43 psi*msec
GLAZING RESPONSE	
Exterior Lite	Fractured
Interior Lite	Unbroken
Glazing Pullout	None
Film Tearing	None
WITNESS CHAMBER RESULTS	
Glazing cracked but remained fully retained. No damage observed to the witness panel.
