AIRBLAST LOADING TEST REPORT

ASTM F1642/GSA TS01 TESTING ON *LLUMAR SCL SR PS8* SAFETY AND SECURITY FILM
INSTALLED ON A FIXED WINDOW SYSTEM
(SINGLE PANE, ANNEALED, SILICONE GLAZING ATTACHMENT)

I4621.09-119-12 R0

11/13/18

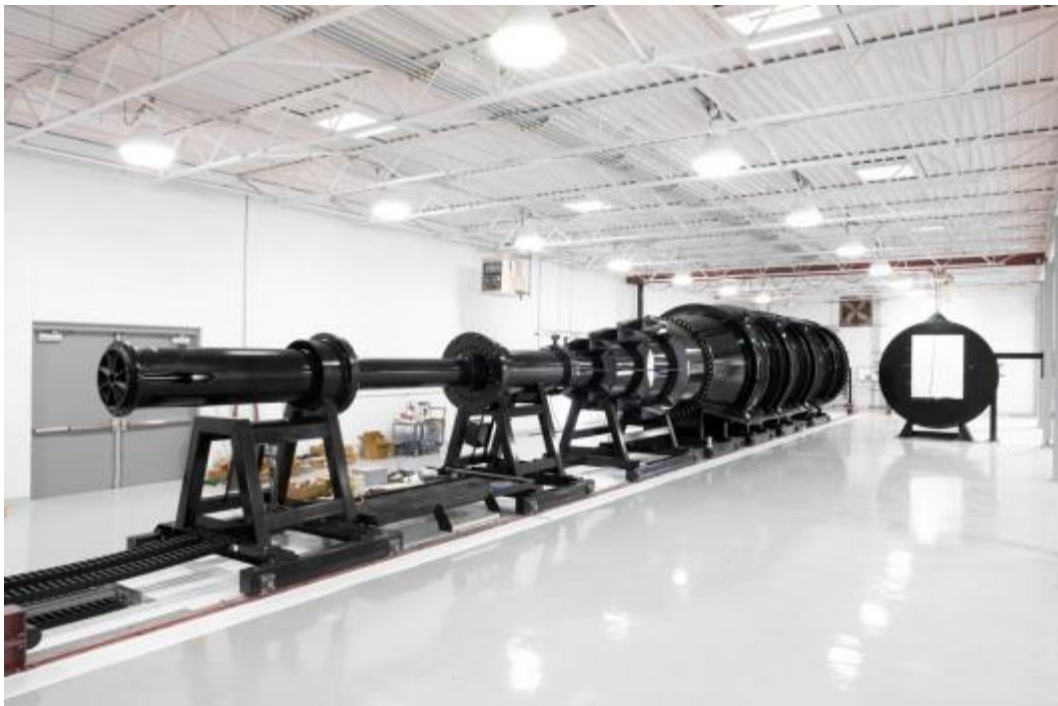
Intertek B&C's shock tube is housed in a 10,000 square foot state-of-the-art test facility located in York, Pennsylvania. A photograph of the shock tube is provided in Figure #1.

Figure #1
Shock Tube and Test Facility

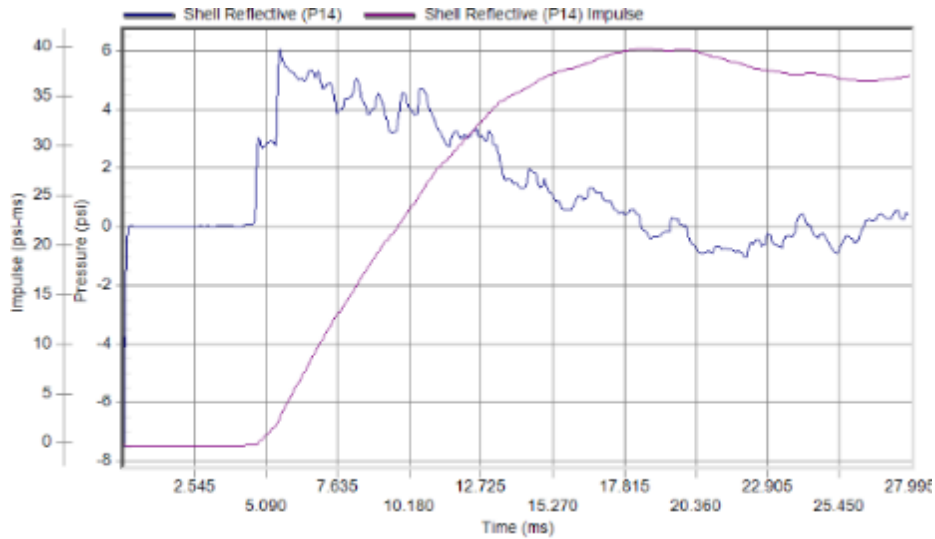
Test Specimen #1 - Pressure Time Plots

Peak Pressure: 6.09 psi at 5.59 ms
Duration: 12.83 ms

DESCRIPTION	RESULTS
Ambient Temperature	81°F
Glazing Temperature	82°F
ASTM Hazard Rating	Minimal Hazard
GSA Performance Condition	2
PEAK POSITIVE PRESSURE	
Top Pressure	6.42 psi
Right Pressure	6.20 psi
Shell Pressure	6.09 psi
Average Pressure	6.24 psi
Witness Chamber Pressure	0.29 psi
PEAK POSITIVE PHASE DURATION	
Top Duration	12.93 msec
Right Duration	8.10 msec
Shell Duration	12.83 msec
Average Duration	11.28 msec
PEAK POSITIVE PHASE IMPULSE	
Top Impulse	40 psi*msec
Right Impulse	40 psi*msec
Shell Impulse	40 psi*msec
Average Impulse	40 psi*msec
GLAZING RESPONSE	
Exterior Lite	Fractured
Interior Lite	N/A
Glazing Pullout Length and Location	8" at bottom left interior, 5-1/4" bottom left interior
Glazing Tearing	10" at bottom left interior, 3" at bottom right interior, 4-1/8" upper right interior, 1-1/4" at left interior
WITNESS CHAMBER RESULTS	
Glazing dust, no fragments

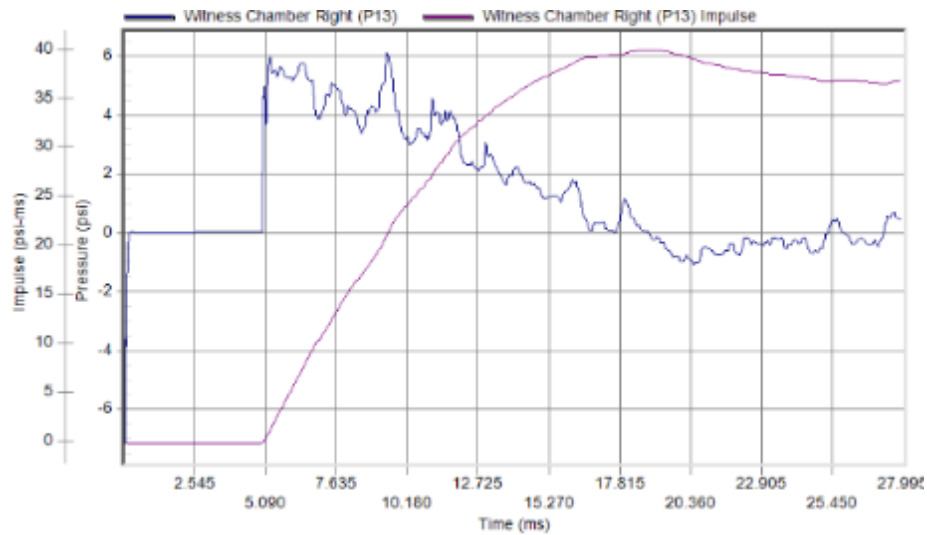
Peak Pressure: 6.20 psi at 9.46 ms
Duration: 8.10 ms

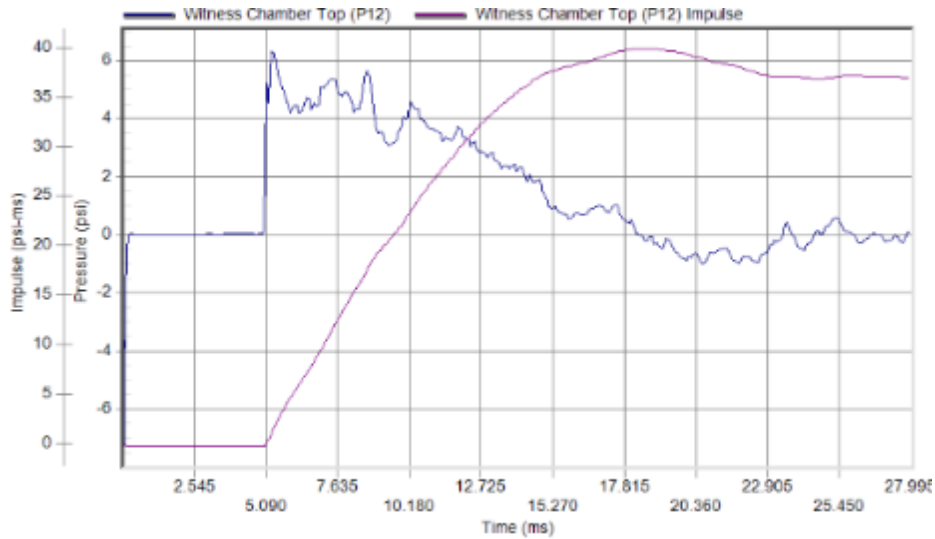
Peak Pressure: 6.42 psi at 5.32 ms
Duration: 12.93 ms

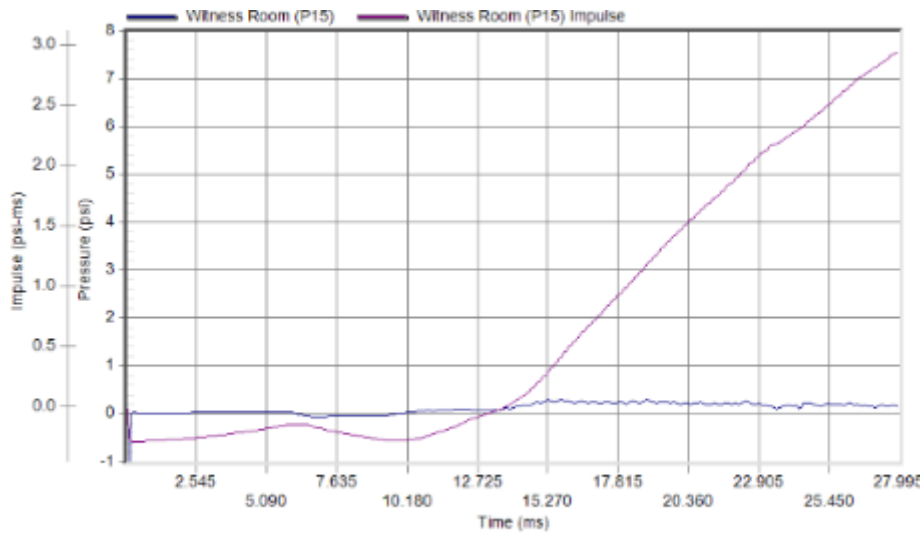
Peak Pressure: 0.29 psi at 15.24 ms
Duration: 0.00 ms

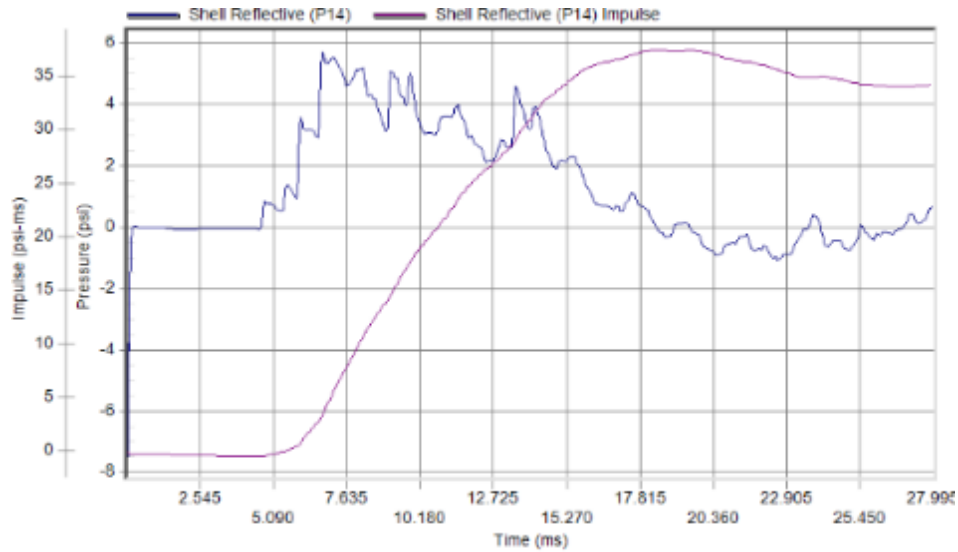
Test Specimen #2 - Pressure Time Plots

Peak Pressure: 5.78 psi at 6.81 ms
Duration: 11.54 ms

DESCRIPTION	RESULTS
Ambient Temperature	83°F
Glazing Temperature	84°F
ASTM Hazard Rating	Minimal Hazard
GSA Performance Condition	2
PEAK POSITIVE PRESSURE	
Top Pressure	6.32 psi
Right Pressure	6.13 psi
Shell Pressure	5.78 psi
Average Pressure	6.08 psi
Witness Chamber Pressure	0.27 psi
PEAK POSITIVE PHASE DURATION	
Top Duration	12.57 msec
Right Duration	11.83 msec
Shell Duration	11.54 msec
Average Duration	11.98 msec
PEAK POSITIVE PHASE IMPULSE	
Top Impulse	38 psi*msec
Right Impulse	38 psi*msec
Shell Impulse	37 psi*msec
Average Impulse	38 psi*msec
GLAZING RESPONSE	
Exterior Lite	Fractured
Interior Lite	N/A
Glazing Pullout Length and Location	None
Glazing Tearing	1/4" at top left interior, 3/4" at top right interior, 1/2" at bottom left interior, 3-1/2" at bottom right interior, 3/8" at bottom right interior
WITNESS CHAMBER RESULTS	
Glazing dust

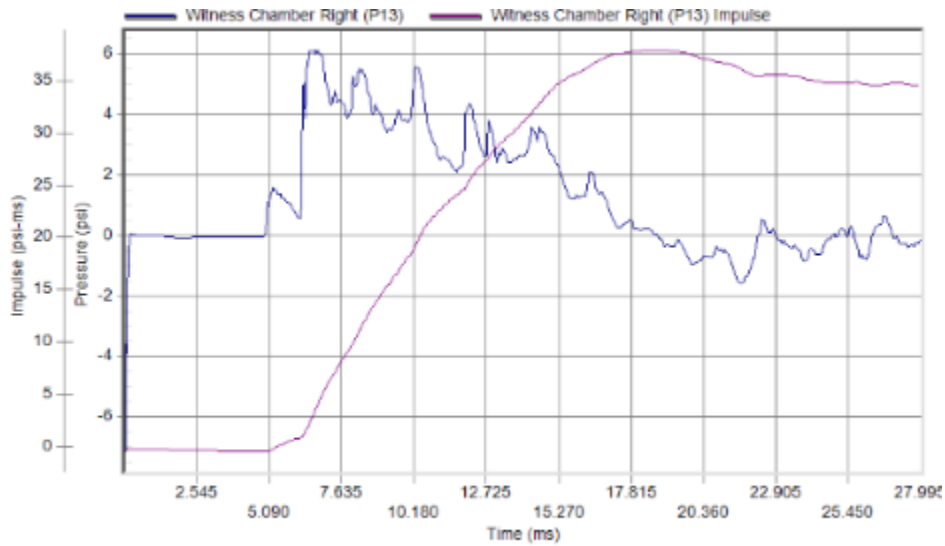
Peak Pressure: 6.13 psi at 6.81 ms
Duration: 11.83 ms

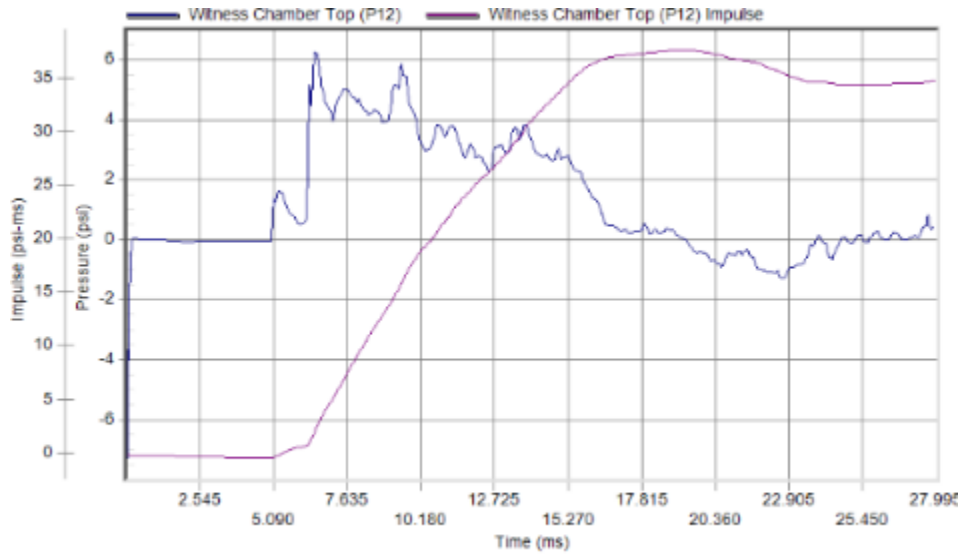
Peak Pressure: 6.32 psi at 6.55 ms
Duration: 12.57 ms

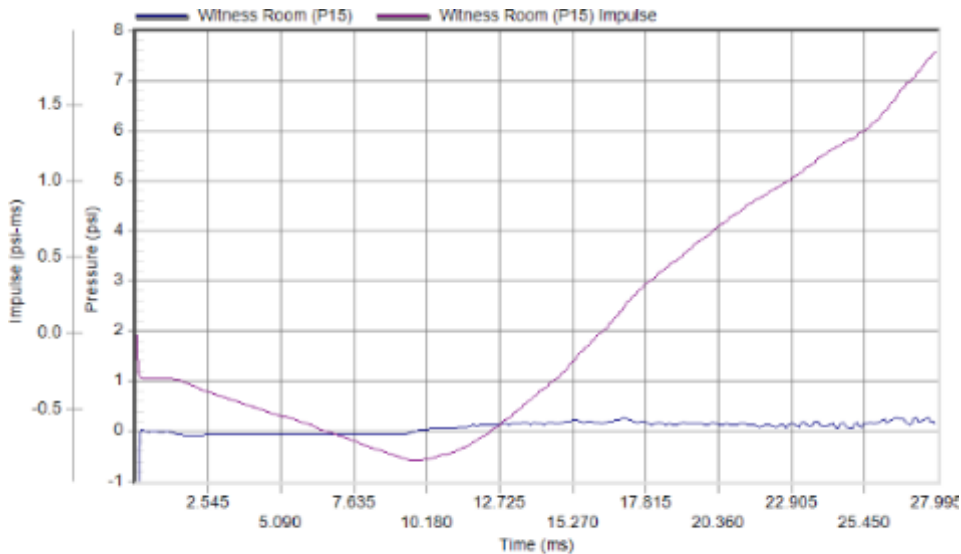
Peak Pressure: 0.27 psi at 27.68 ms
Duration: 0.00 ms

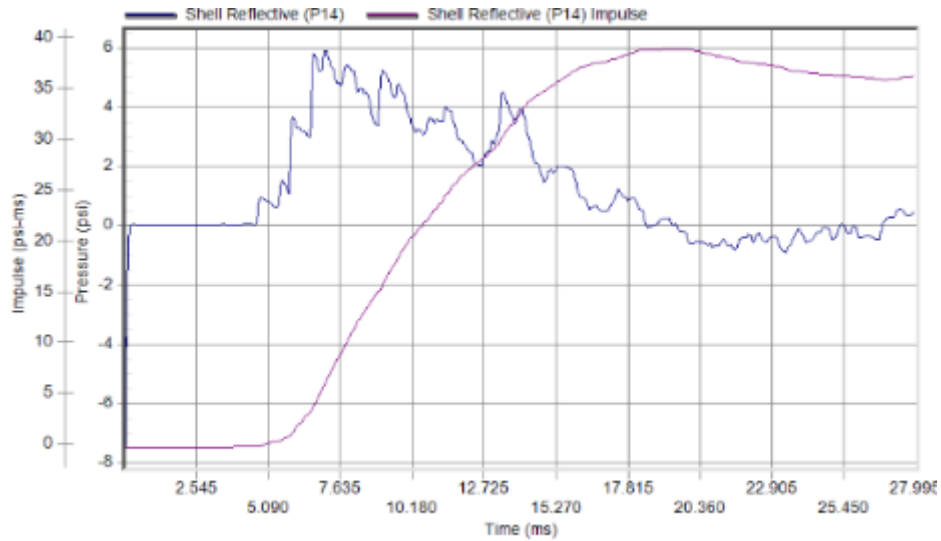
Test Specimen #3 - Pressure Time Plots

Peak Pressure: 5.96 psi at 7.12 ms
Duration: 11.33 ms

DESCRIPTION	RESULTS
Ambient Temperature	79°F
Glazing Temperature	82°F
ASTM Hazard Rating	Minimal Hazard
GSA Performance Condition	2
PEAK POSITIVE PRESSURE	
Top Pressure	6.47 psi
Right Pressure	6.27 psi
Shell Pressure	5.96 psi
Average Pressure	6.23 psi
Witness Chamber Pressure	0.43 psi
PEAK POSITIVE PHASE DURATION	
Top Duration	10.72 msec
Right Duration	12.32 msec
Shell Duration	11.33 msec
Average Duration	11.46 msec
PEAK POSITIVE PHASE IMPULSE	
Top Impulse	39 psi*msec
Right Impulse	39 psi*msec
Shell Impulse	39 psi*msec
Average Impulse	39 psi*msec
GLAZING RESPONSE	
Exterior Lite	Fractured
Interior Lite	N/A
Glazing Pullout Length and Location	None
Glazing Tearing	7-1/8" at bottom left interior, 7/8" at top left interior, 1-1/2" by 1-1/4" at upper right corner interior, 3-1/4" at upper right interior, 6-1/2" lower right interior, 1/8" at lower right interior, 3/4" in at center of interior
WITNESS CHAMBER RESULTS	
Glazing dust

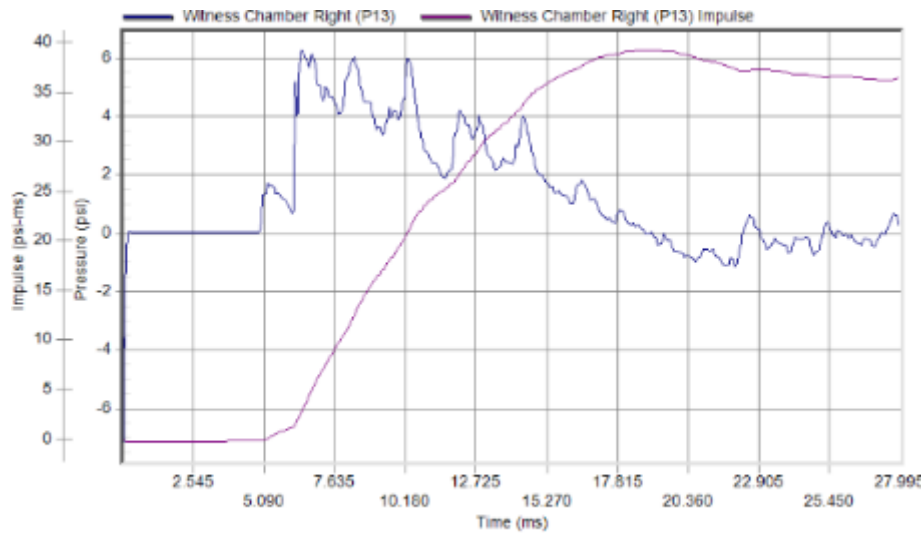
Peak Pressure: 6.27 psi at 6.46 ms
Duration: 12.32 ms

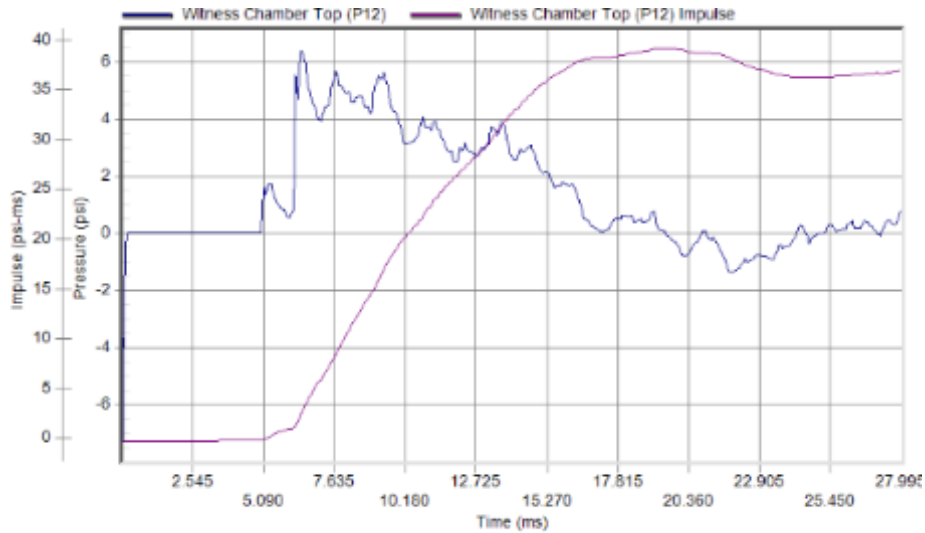
Peak Pressure: 6.47 psi at 6.47 ms
Duration: 10.72 ms

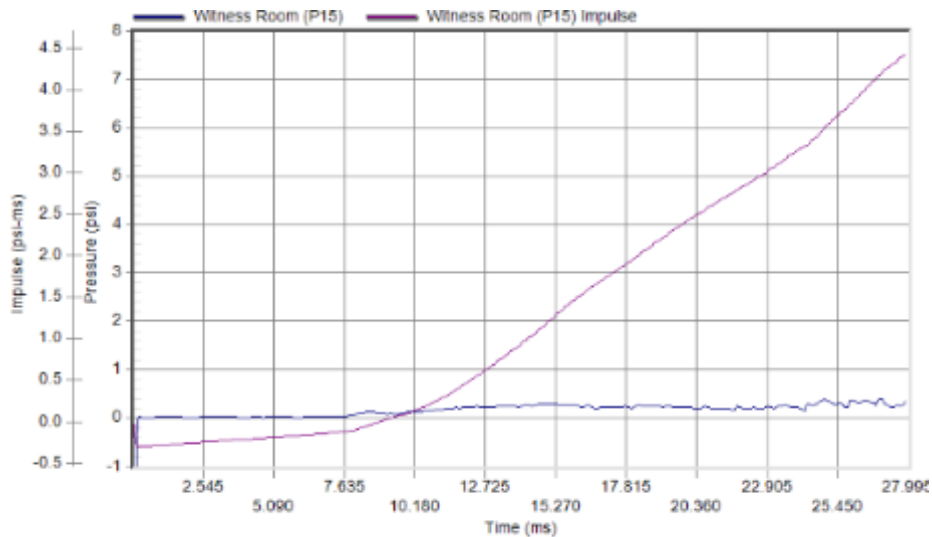
Peak Pressure: 0.43 psi at 27.00 ms
Duration: 0.00 ms

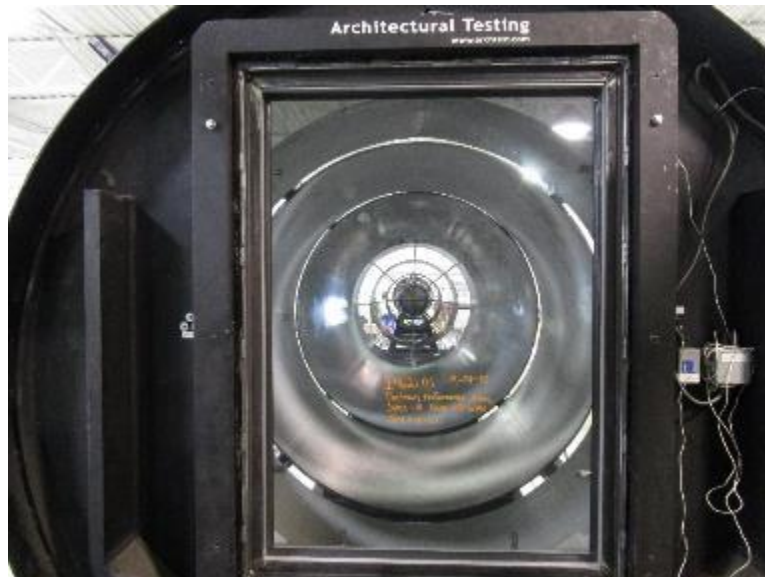
Photo No. 1
Pre-test Specimen #1, Interior

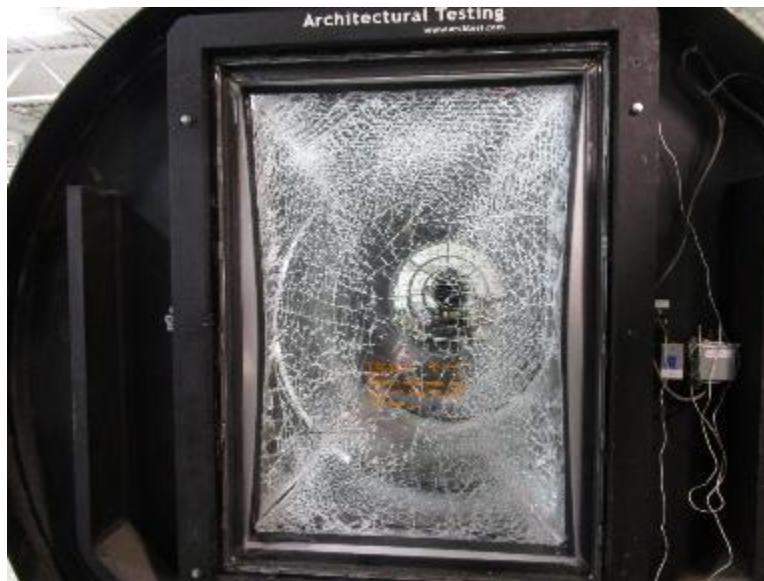
Photo No. 2
Post-test Specimen #1, Interior

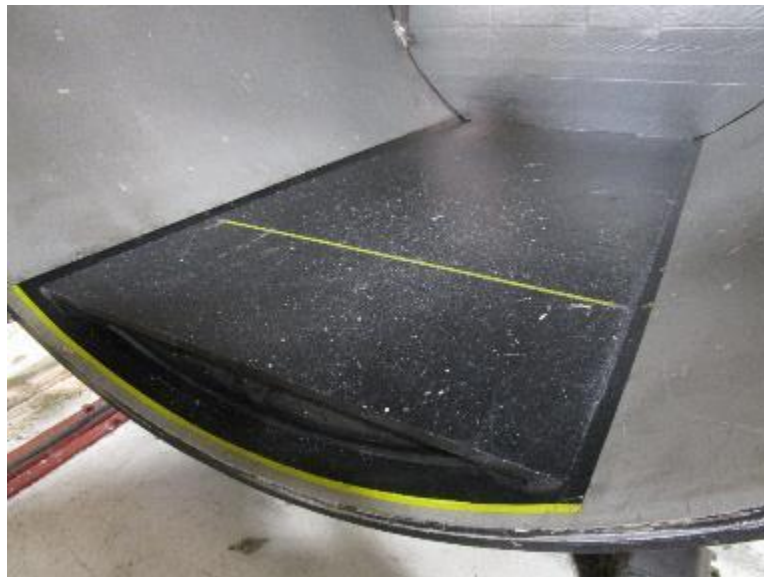
Photo No. 3
Post-test Specimen #1, Witness Chamber

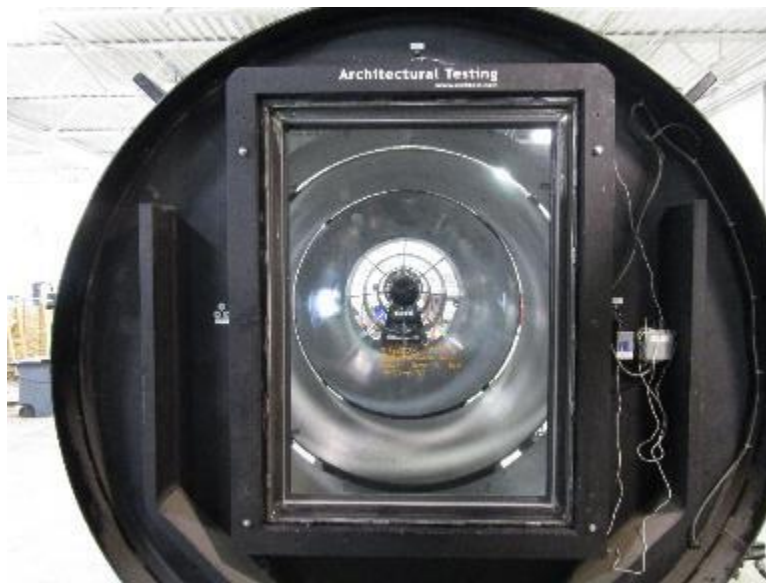
Photo No. 4
Pre-test Specimen #2, Interior

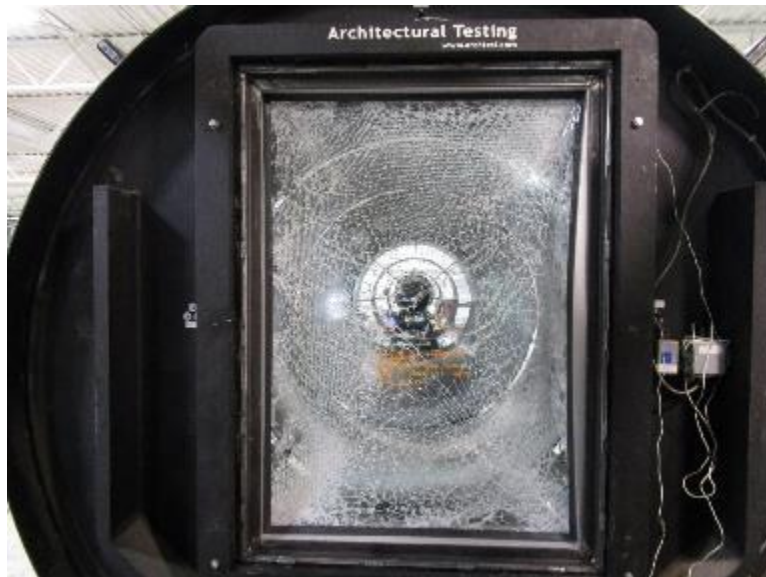
Photo No. 5
Post-test Specimen #2, Interior

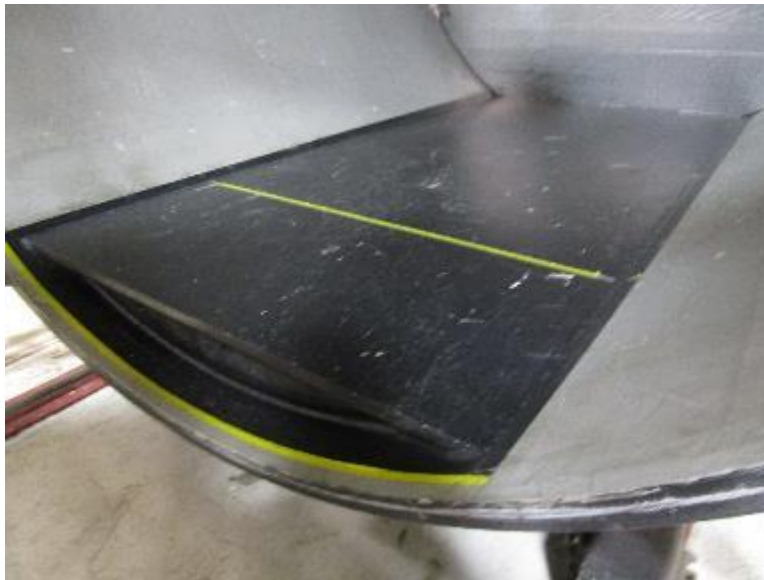
Photo No. 6
Post-test Specimen #2, Witness Chamber

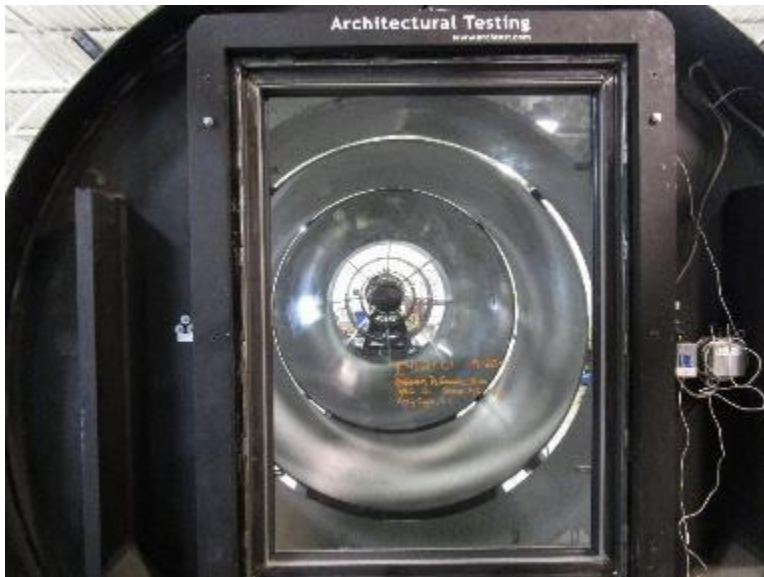
Photo No. 7
Pre-test Specimen #3, Interior

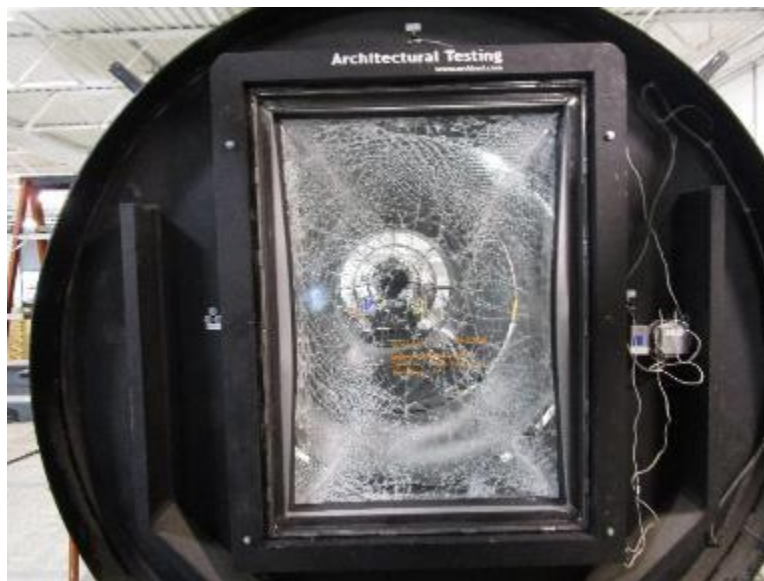
Photo No. 8
Post-test Specimen #3, Interior

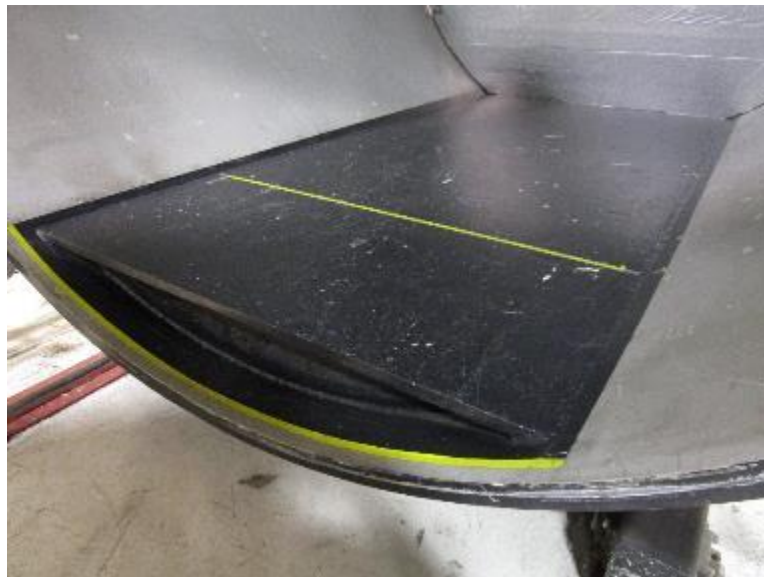
Photo No. 9
Post-test Specimen #3, Witness Chamber

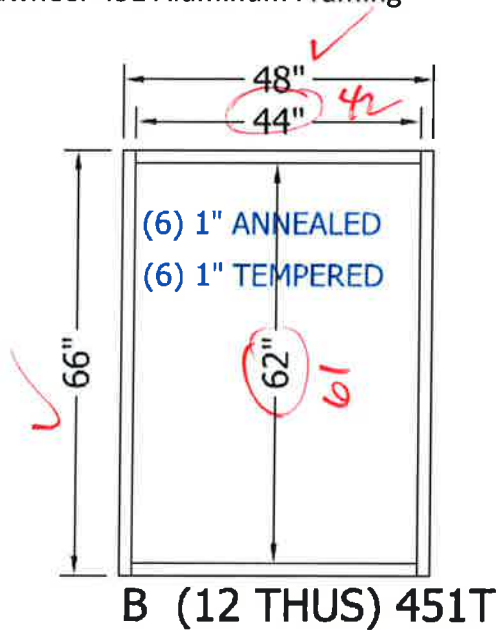
Dual-pane unit frames

Kawneer 451 Aluminum Framing

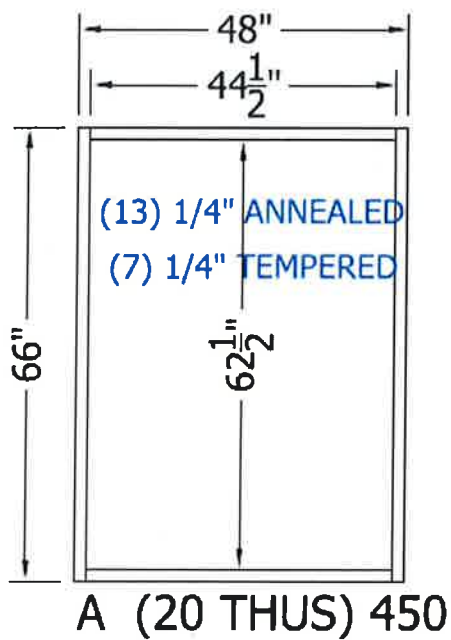
Single-pane unit frames

Kawneer 450 Aluminum Framing

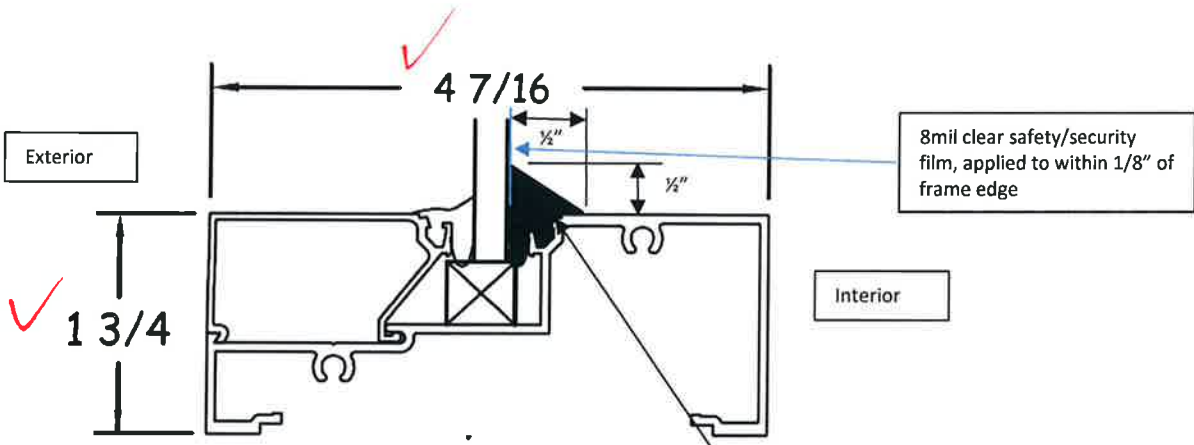
SILL
DETAIL F9

Glass:
single-pane or dual-pane
(single-pane shown)
