EASTMAN PERFORMANCE FILMS, LLC

AIRBLAST LOADING TEST REPORT

ASTM F1642/GSA TS01 TESTING ON DR25 SR PS9 SAFETY AND SECURITY PERFORMANCE FILM
INSTALLED ON A FIXED WINDOW SYSTEM
(DUAL PANE, TEMPERED, SILICONE GLAZING ATTACHMENT)

J3983.11-119-12 R0

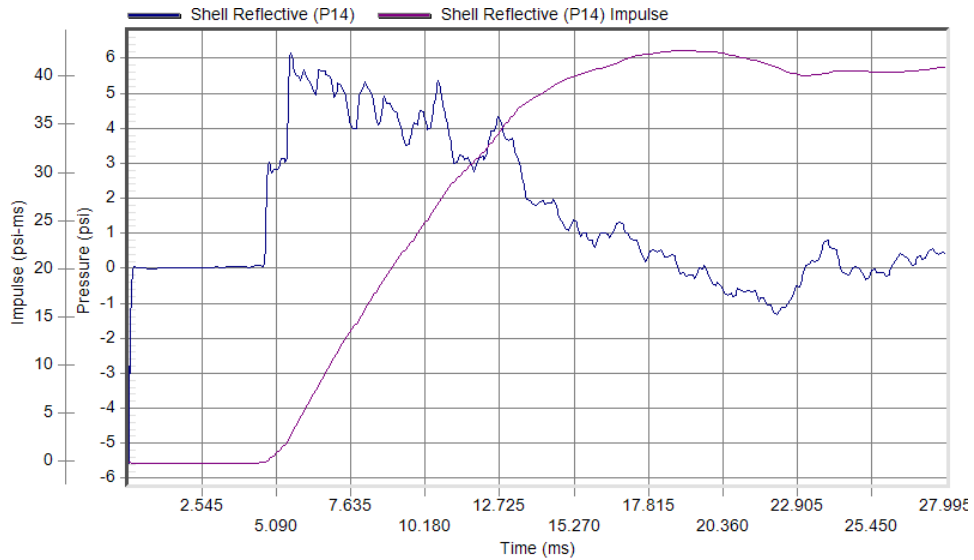
Test Specimen #1 - Pressure Time Plots

Peak Pressure: 6.23 psi at 5.59 ms
Duration: 13.21 ms

DESCRIPTION	RESULTS
Ambient Temperature	87°F
Glazing Temperature	89°F
ASTM Hazard Rating	No Break
GSA Performance Condition	1
PEAK POSITIVE PRESSURE	
Top Pressure	6.58 psi
Right Pressure	6.38 psi
Shell Pressure	6.23 psi
Average Pressure	6.39 psi
Witness Chamber Pressure	0.21 psi
PEAK POSITIVE PHASE DURATION	
Top Duration	12.51 msec
Right Duration	12.00 msec
Shell Duration	13.21 msec
Average Duration	12.57 msec
PEAK POSITIVE PHASE IMPULSE	
Top Impulse	44 psi*msec
Right Impulse	44 psi*msec
Shell Impulse	43 psi*msec
Average Impulse	44 psi*msec
GLAZING RESPONSE	
Exterior Lite	Unbroken
Interior Lite	Unbroken
Glazing Pullout	None
Film Tearing	None
WITNESS CHAMBER RESULTS	
No debris was observed.

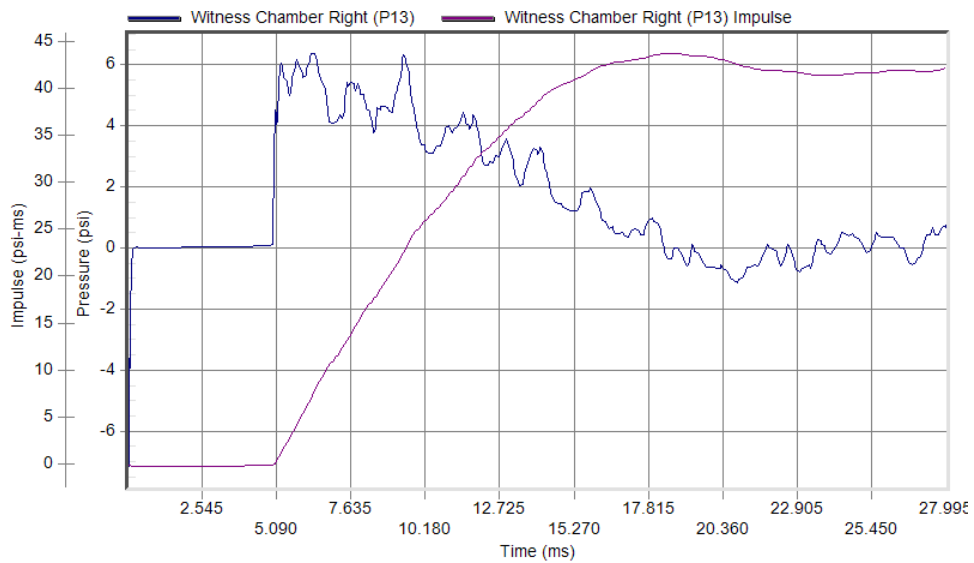
Peak Pressure: 6.38 psi at 6.34 ms
Duration: 12.00 ms

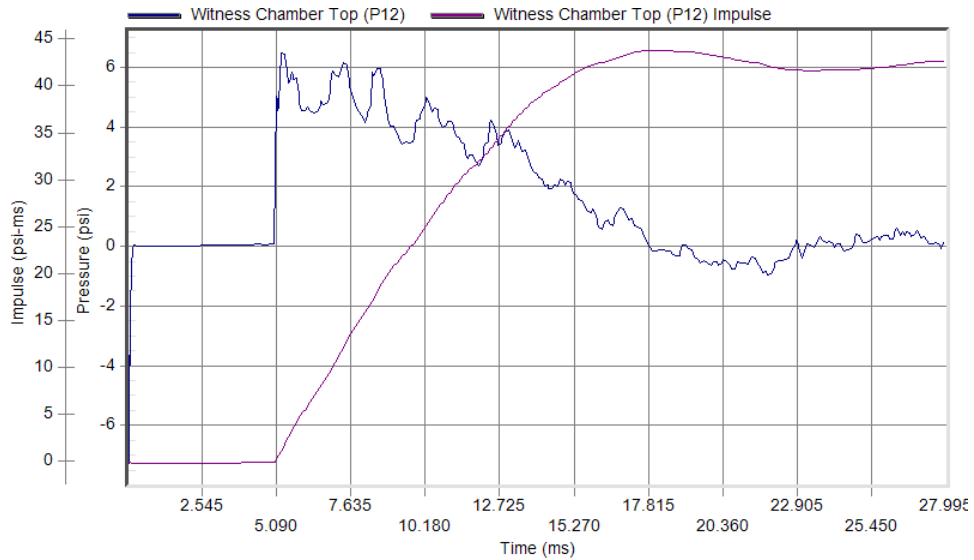
Test Specimen #1 - Pressure Time Plots (continued)

Peak Pressure: 6.58 psi at 5.32 ms
Duration: 12.51 ms

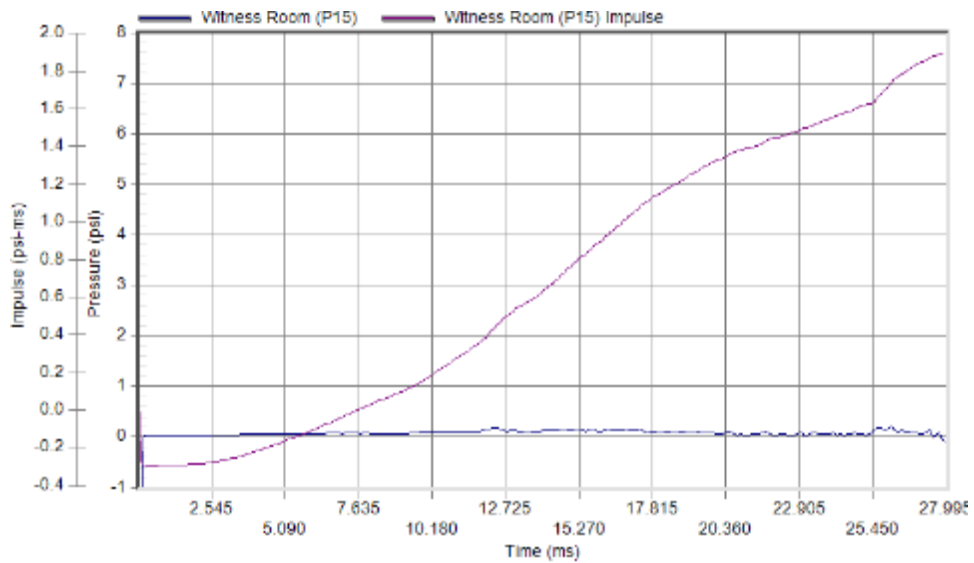
Peak Pressure: 0.21 psi at 26.02 ms
Duration: 1.52 ms

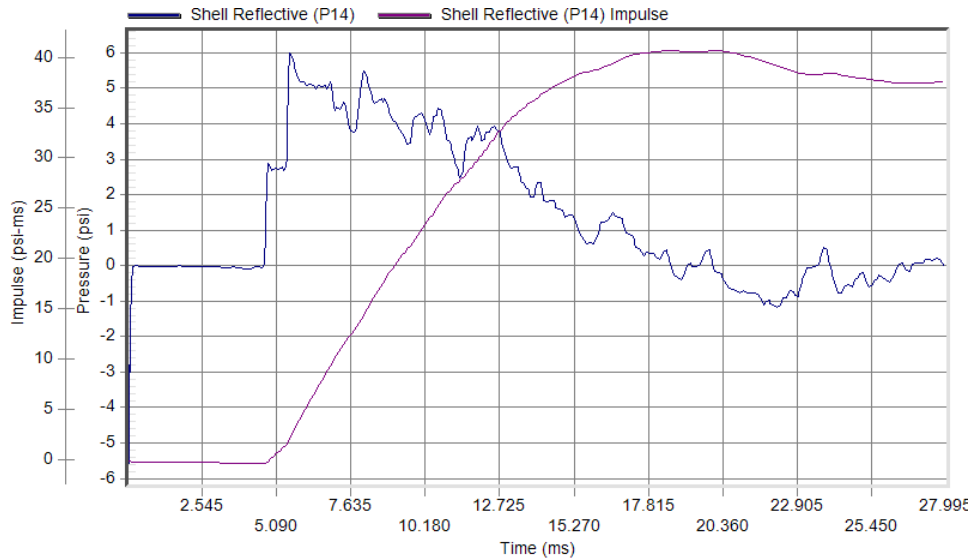
Test Specimen #2 - Pressure Time Plots

Peak Pressure: 6.07 psi at 5.58 ms
Duration: 12.98 ms

DESCRIPTION	RESULTS
Ambient Temperature	89°F
Glazing Temperature	91°F
ASTM Hazard Rating	No Break
GSA Performance Condition	1
PEAK POSITIVE PRESSURE	
Top Pressure	6.66 psi
Right Pressure	5.96 psi
Shell Pressure	6.07 psi
Average Pressure	6.23 psi
Witness Chamber Pressure	0.13 psi
PEAK POSITIVE PHASE DURATION	
Top Duration	13.20 msec
Right Duration	11.64 msec
Shell Duration	12.98 msec
Average Duration	12.61 msec
PEAK POSITIVE PHASE IMPULSE	
Top Impulse	41 psi*msec
Right Impulse	41 psi*msec
Shell Impulse	41 psi*msec
Average Impulse	41 psi*msec
GLAZING RESPONSE	
Exterior Lite	Unbroken
Interior Lite	Unbroken
Glazing Pullout	None
Film Tearing	None
WITNESS CHAMBER RESULTS	
No debris was observed.

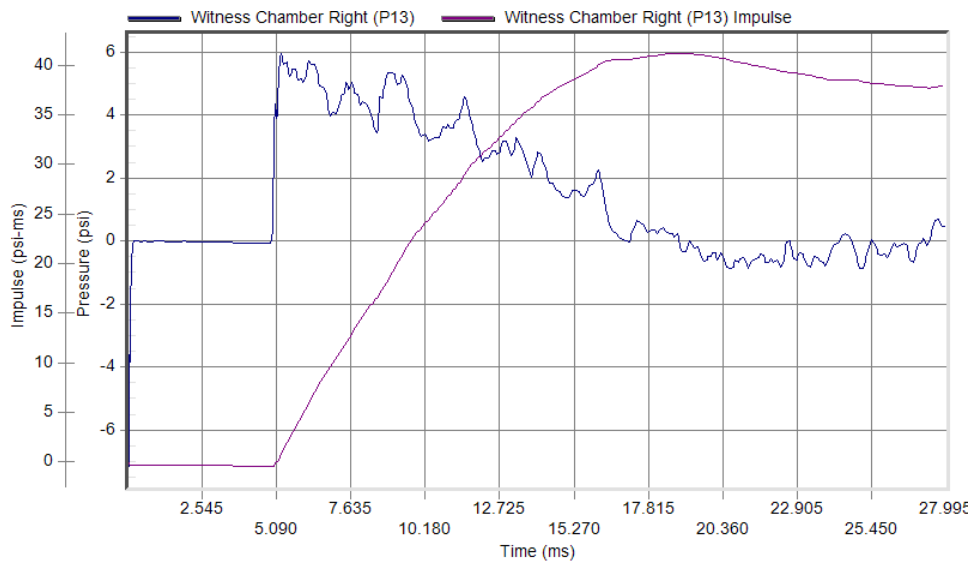
Peak Pressure: 5.96 psi at 5.26 ms
Duration: 11.64 ms

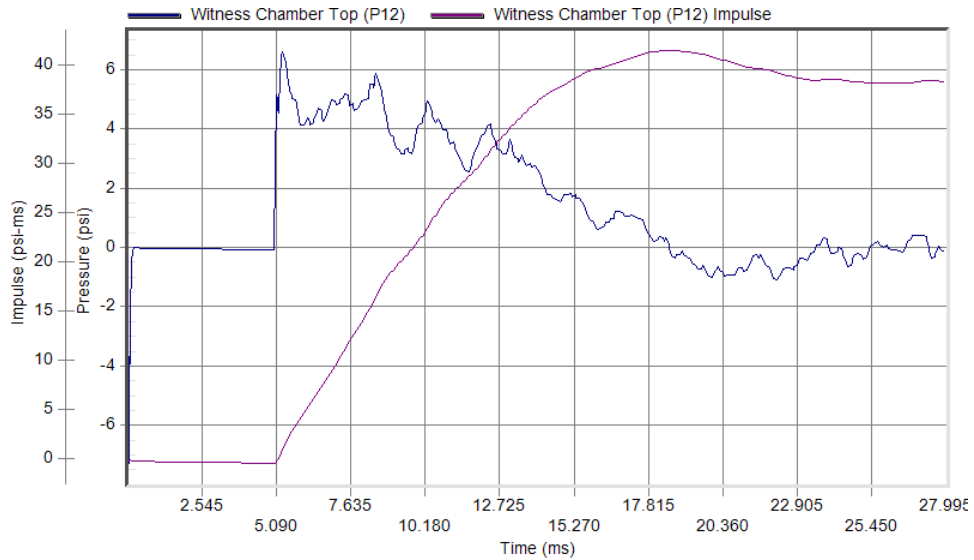
Test Specimen #2 - Pressure Time Plots (continued)

Peak Pressure: 6.66 psi at 5.32 ms
Duration: 13.20 ms

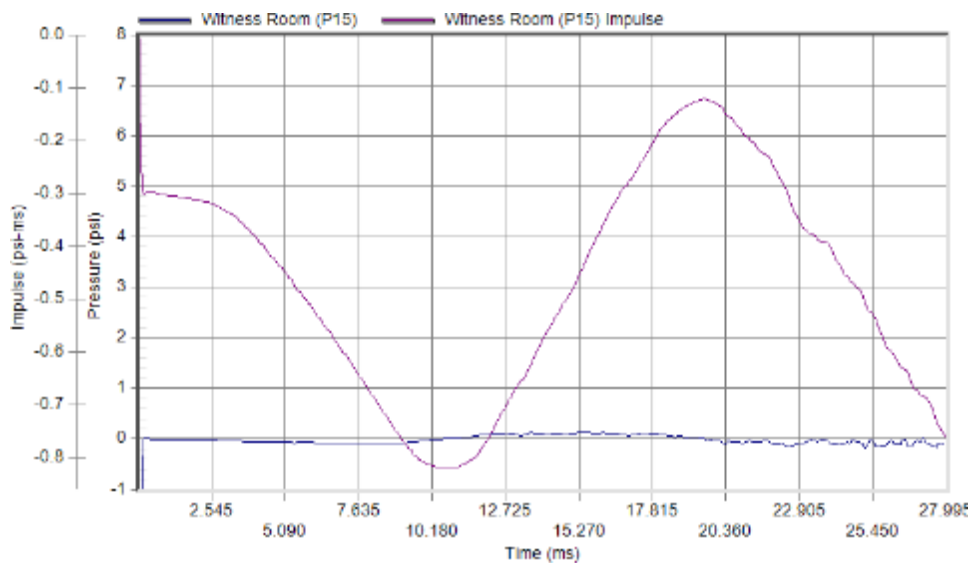
Peak Pressure: 0.13 psi at 15.35 ms
Duration: 4.25 ms

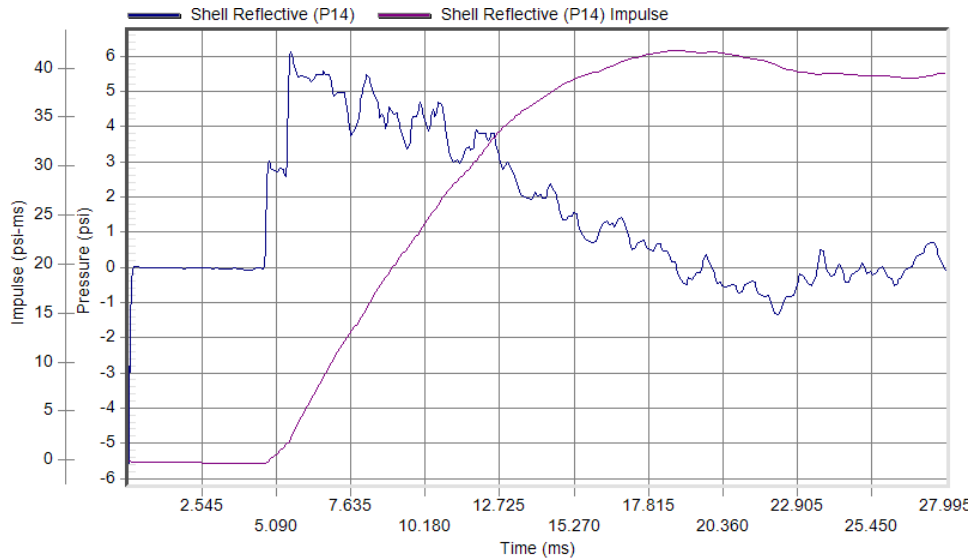
Test Specimen #3 - Pressure Time Plots

Peak Pressure: 6.17 psi at 5.61 ms
Duration: 13.14 ms

DESCRIPTION	RESULTS
Ambient Temperature	90°F
Glazing Temperature	96°F
ASTM Hazard Rating	No Break
GSA Performance Condition	1
PEAK POSITIVE PRESSURE	
Top Pressure	6.80 psi
Right Pressure	6.22 psi
Shell Pressure	6.17 psi
Average Pressure	6.40 psi
Witness Chamber Pressure	0.17 psi
PEAK POSITIVE PHASE DURATION	
Top Duration	13.11 msec
Right Duration	12.14 msec
Shell Duration	13.14 msec
Average Duration	12.80 msec
PEAK POSITIVE PHASE IMPULSE	
Top Impulse	42 psi*msec
Right Impulse	42 psi*msec
Shell Impulse	42 psi*msec
Average Impulse	42 psi*msec
GLAZING RESPONSE	
Exterior Lite	Unbroken
Interior Lite	Unbroken
Glazing Pullout	None
Film Tearing	None
WITNESS CHAMBER RESULTS	
No debris was observed.

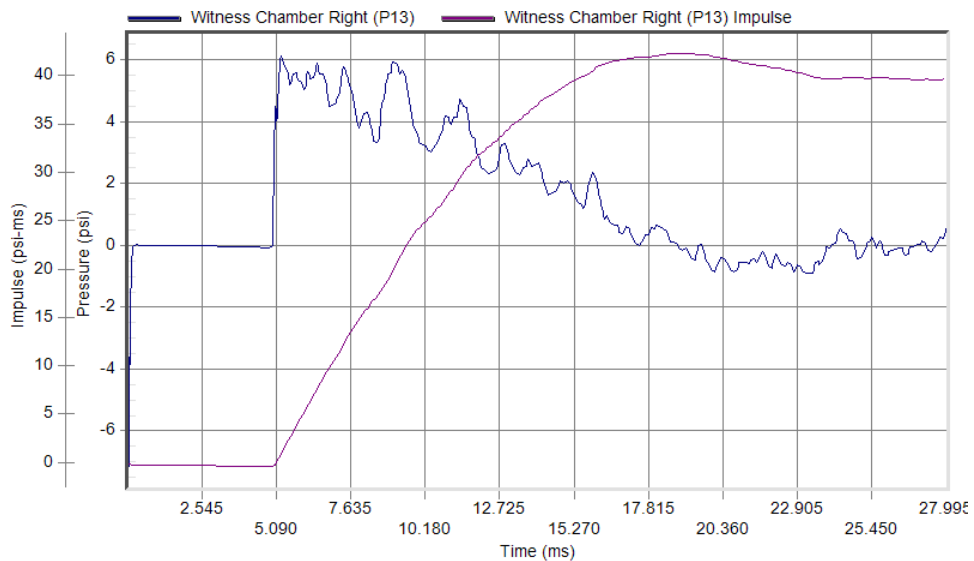
Peak Pressure: 6.22 psi at 5.27 ms
Duration: 12.14 ms

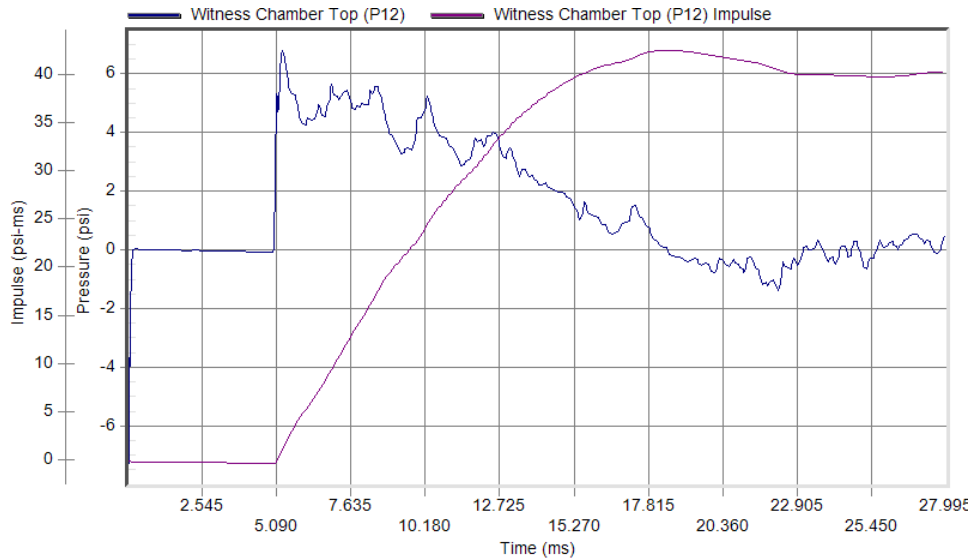
Test Specimen #3 - Pressure Time Plots (continued)

Peak Pressure: 6.80 psi at 5.32 ms
Duration: 13.11 ms

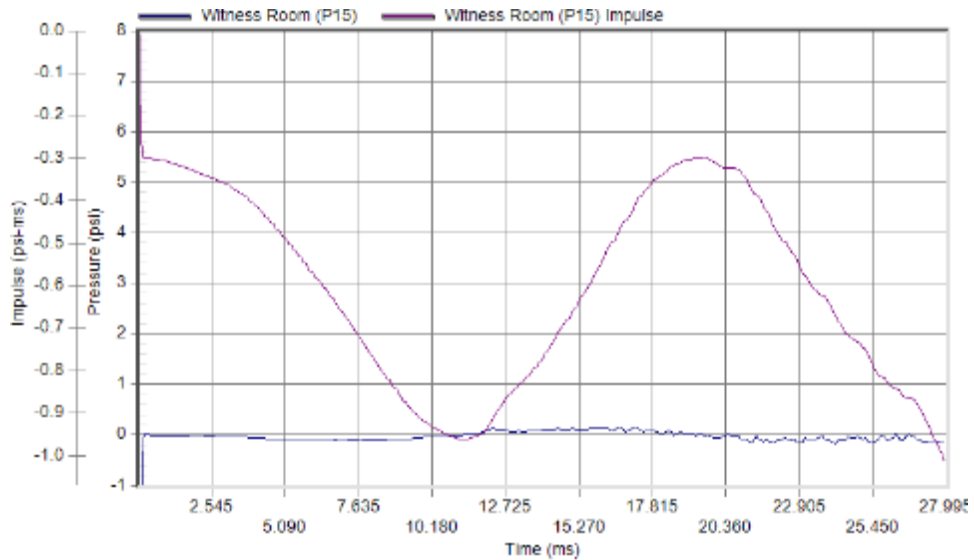
Peak Pressure: 0.17 psi at 17.17 ms
Duration: 1.40 ms

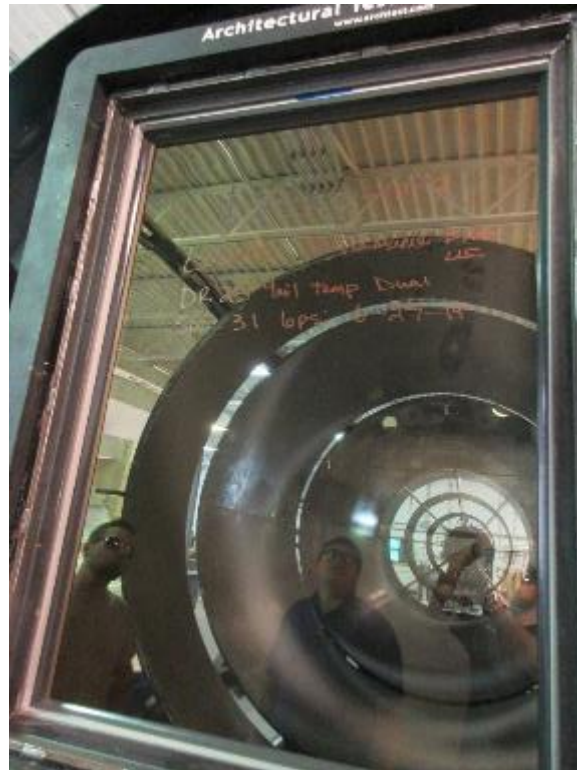
Photo No. 1
Pre-test Specimen #1, Interior

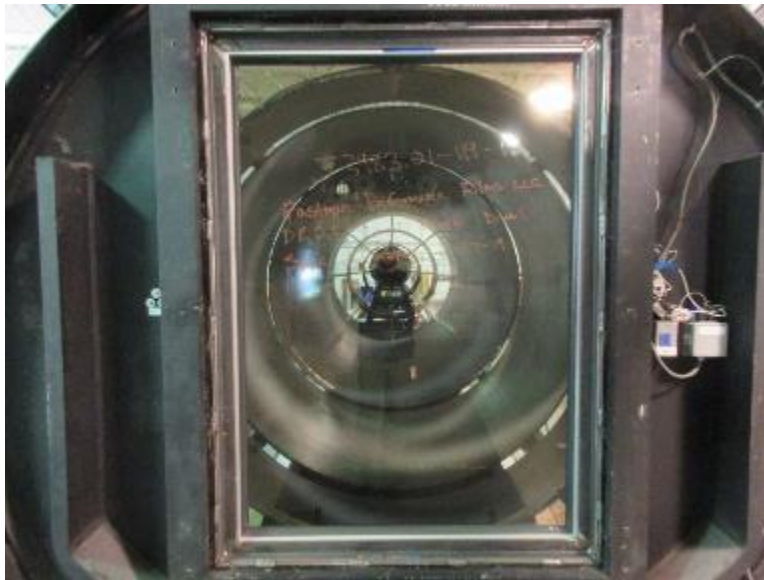
Photo No. 2
Pre-test Specimen #2, Interior

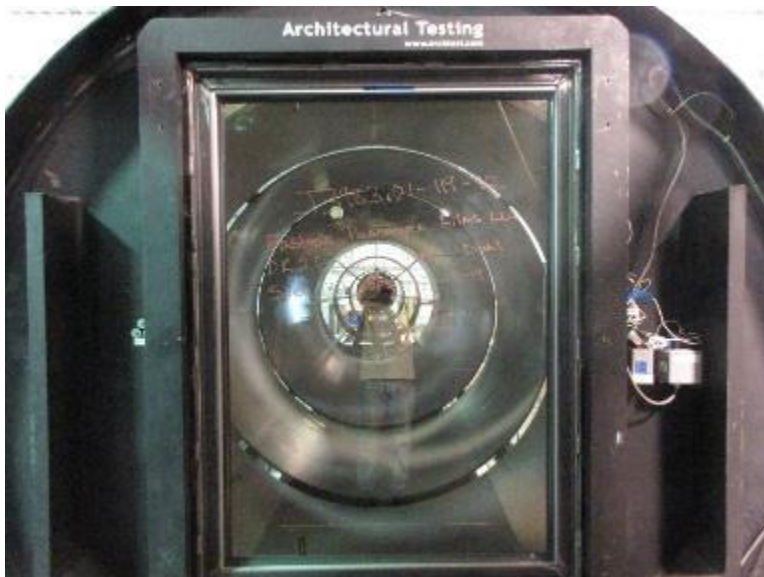
Photo No. 3
Post-test Specimen #2, Interior

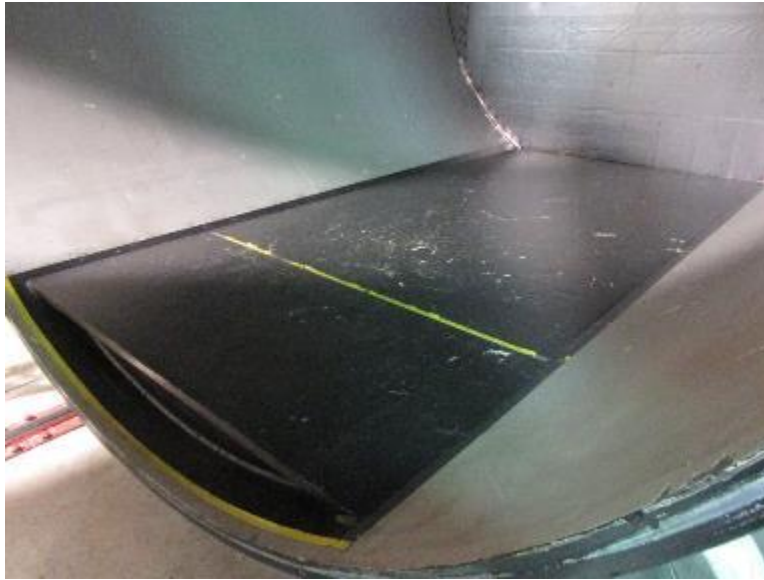
Photo No. 4
Post-test Specimen #2, Witness Chamber

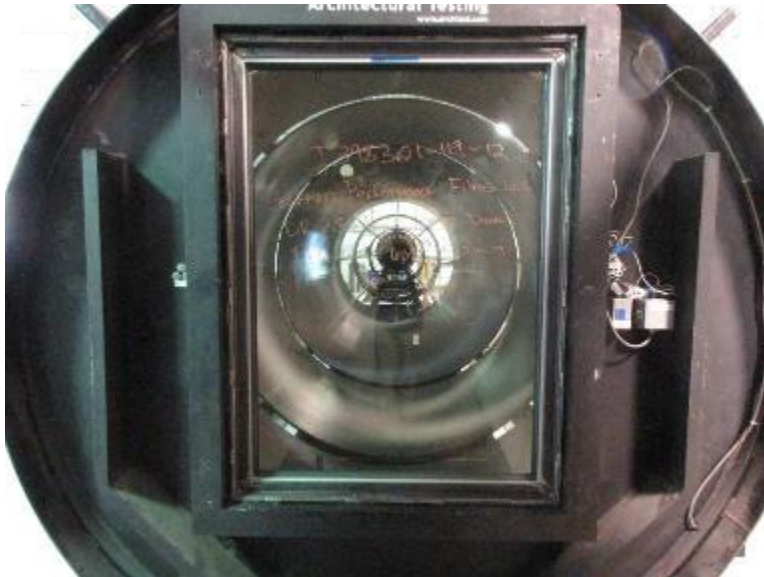
Photo No. 5
Pre-test Specimen #3, Interior

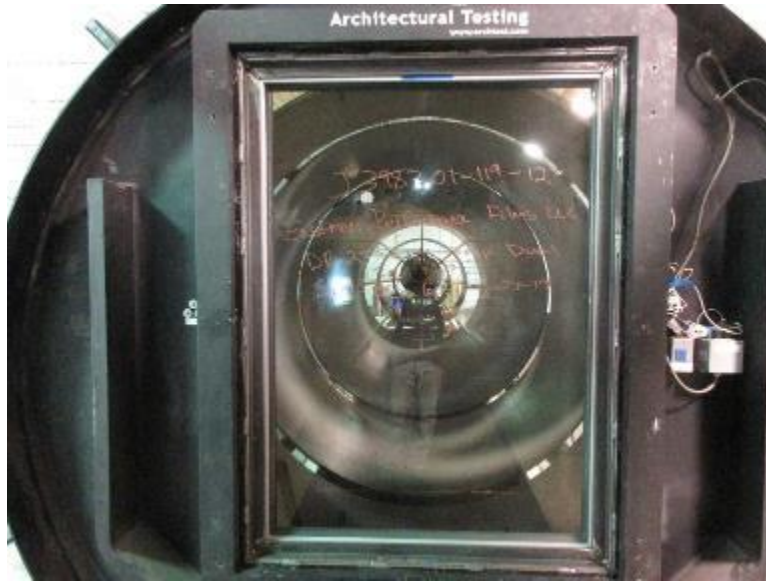
Photo No. 6
Post-test Specimen #3, Interior

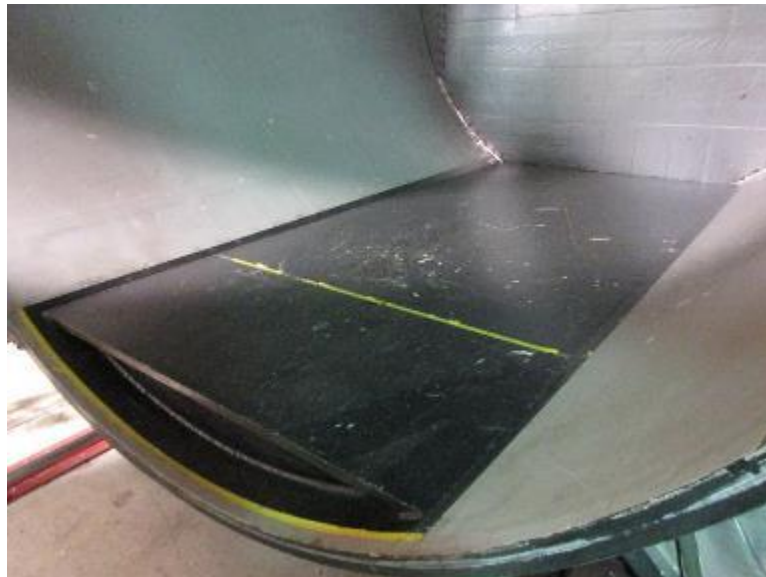
Photo No. 7
Post-test Specimen #3, Witness Chamber

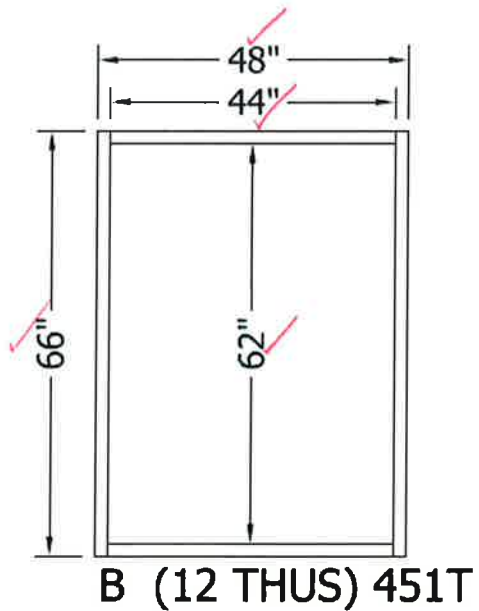
Dual-pane unit frames

Kawneer 451 Aluminum Framing

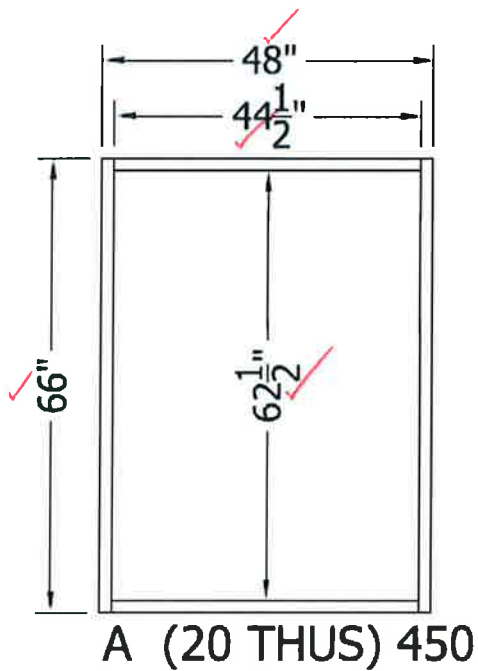
Single-pane unit frames

Kawneer 450 Aluminum Framing
