AIRBLAST LOADING TEST REPORT

ASTM F1642/GSA TS01 TESTING ON *DR15 SR PS9* SAFETY AND SECURITY PERFORMANCE FILM
INSTALLED ON A FIXED WINDOW SYSTEM
(SINGLE PANE, ANNEALED, SILICONE GLAZING ATTACHMENT)

J3983.01-119-12 R0

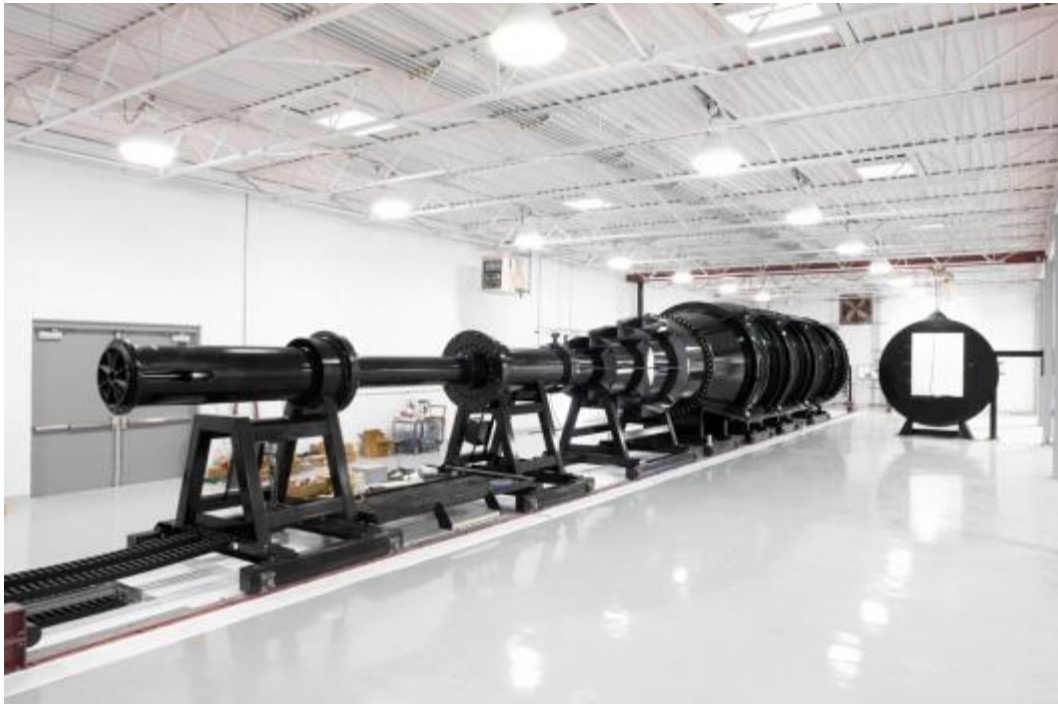
Figure #1
Shock Tube and Test Facility

Intertek B&C's shock tube is housed in a 10,000 square foot state-of-the-art test facility located in York, Pennsylvania. A photograph of the shock tube is provided in Figure #1.

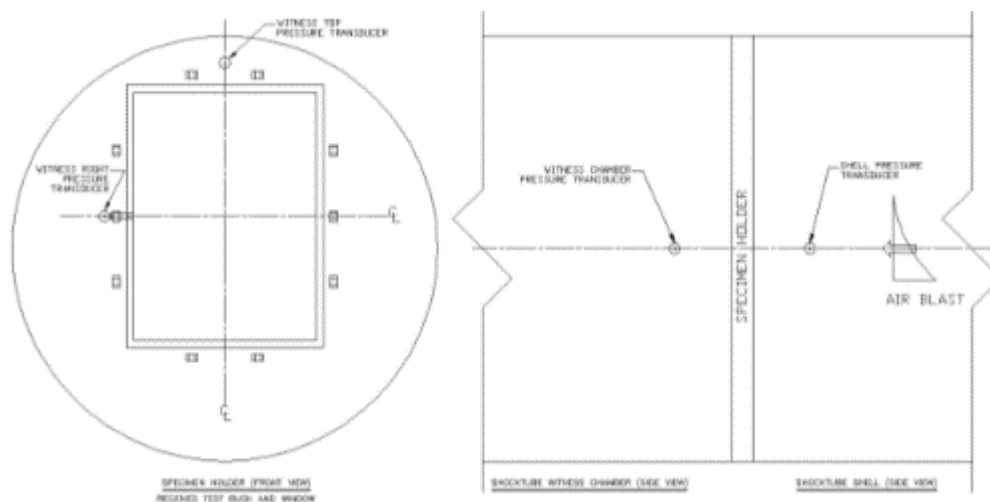
Figure #2
Pressure Sensor Locations

In accordance with ASTM F1642 and GSA TS01, four reflective pressure transducers were utilized for data acquisition at a 1MHz sample rate. Two reflective pressure transducers were located on the specimen holder at the top and right side (when viewed from the interior). A third pressure transducer was located on the shell to the exterior of the specimen, and a fourth was located in the witness chamber, directly to the interior of the specimen holder. A sketch of the specimen holder and corresponding reflective pressure sensor locations is provided in Figure #2.

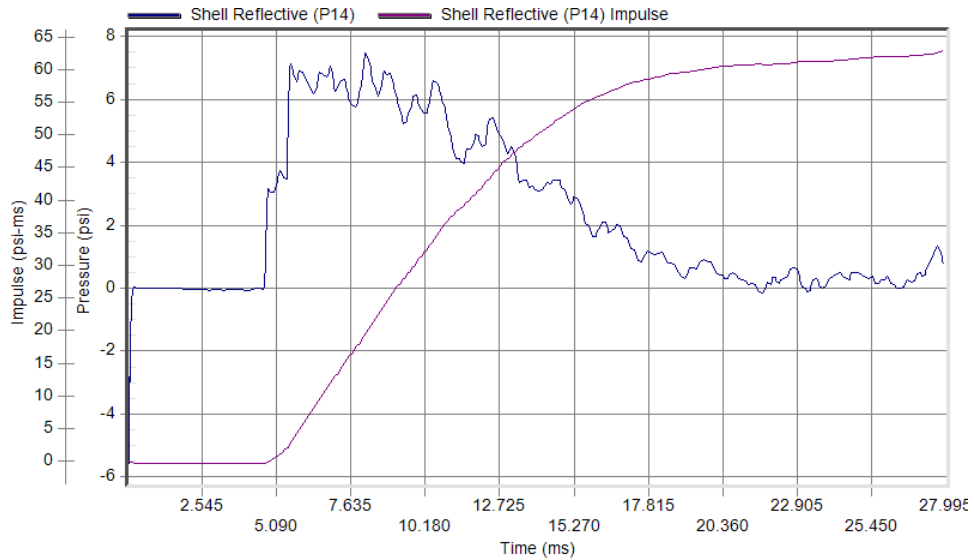
Test Specimen #1 - Pressure Time Plots

Peak Pressure: 7.56 psi at 8.15 ms
Duration: 13.31 ms

DESCRIPTION	RESULTS
Ambient Temperature	80°F
Glazing Temperature	82°F
ASTM Hazard Rating	Very Low Hazard
GSA Performance Condition	3a
PEAK POSITIVE PRESSURE	
Top Pressure	8.09 psi
Right Pressure	7.98 psi
Shell Pressure	7.56 psi
Average Pressure	7.88 psi
Witness Chamber Pressure	0.44 psi
PEAK POSITIVE PHASE DURATION	
Top Duration	12.53 msec
Right Duration	11.03 msec
Shell Duration	13.31 msec
Average Duration	12.29 msec
PEAK POSITIVE PHASE IMPULSE	
Top Impulse	61 psi*msec
Right Impulse	61 psi*msec
Shell Impulse	60 psi*msec
Average Impulse	61 psi*msec
GLAZING RESPONSE	
Exterior Lite	Fractured
Interior Lite	N/A
Glazing Pullout	Glazing pullout at corners
Film Tearing	Film tore at corners
WITNESS CHAMBER RESULTS	
Glass was deposited on the witness chamber floor and six indents were observed on the witness panel below the 20" mark. The sum of fragments on the witness chamber floor between the 1 m and 3 m marks was 11.1g. There were six indents located below the height of 20" on the witness panel. Blast pressures exceeded target pressure.

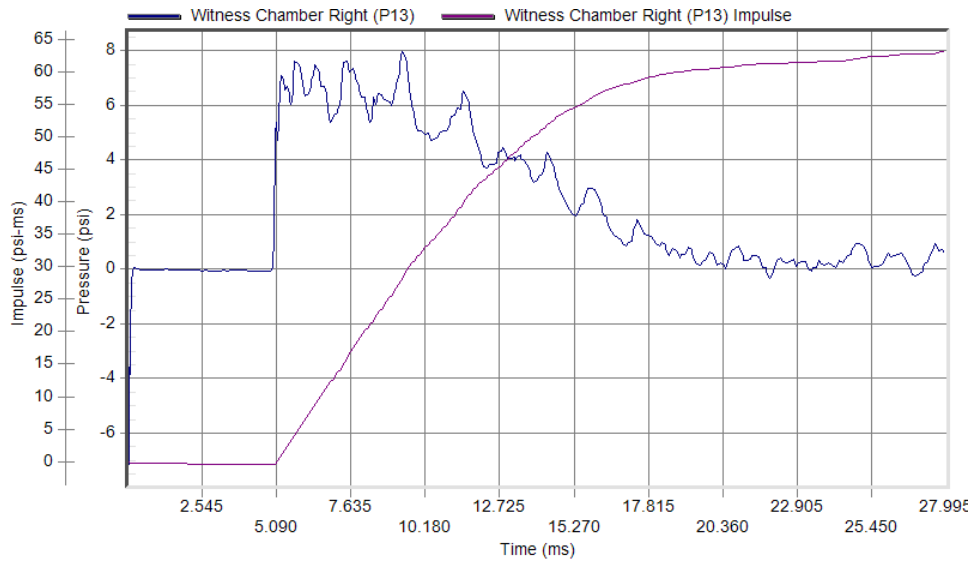
Peak Pressure: 7.98 psi at 9.39 ms
Duration: 11.03 ms

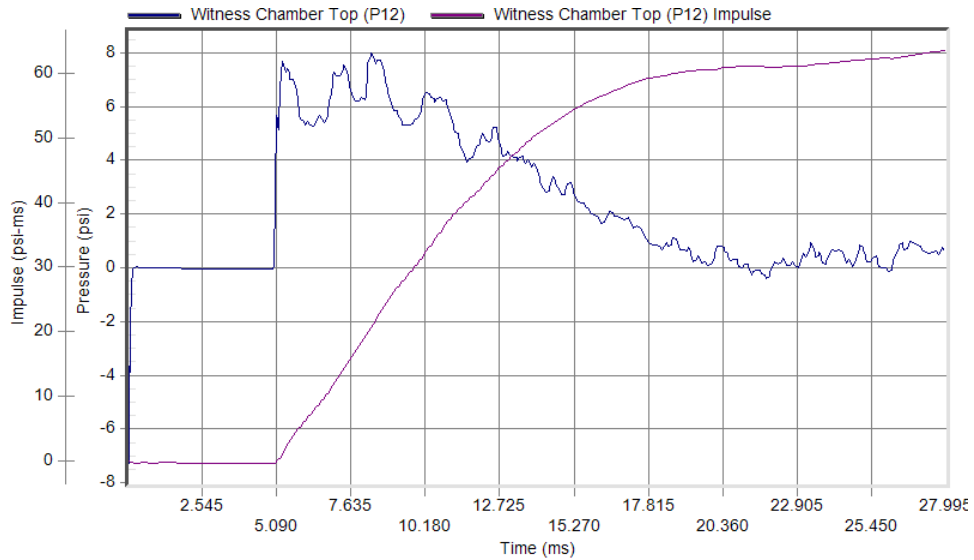
Test Specimen #1 - Pressure Time Plots (continued)

Peak Pressure: 8.09 psi at 8.38 ms
Duration: 12.53 ms

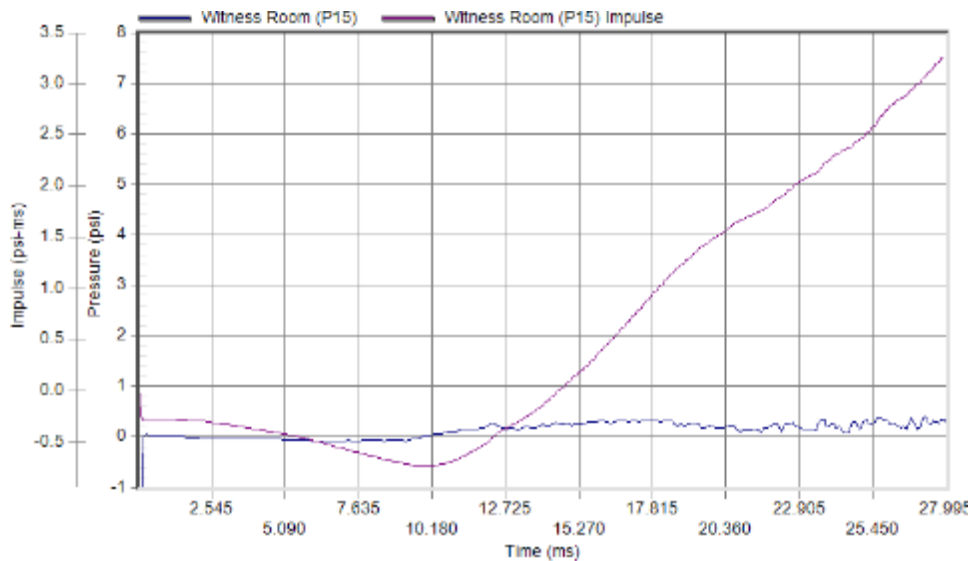
Peak Pressure: 0.44 psi at 27.28 ms
Duration: 1.32 ms

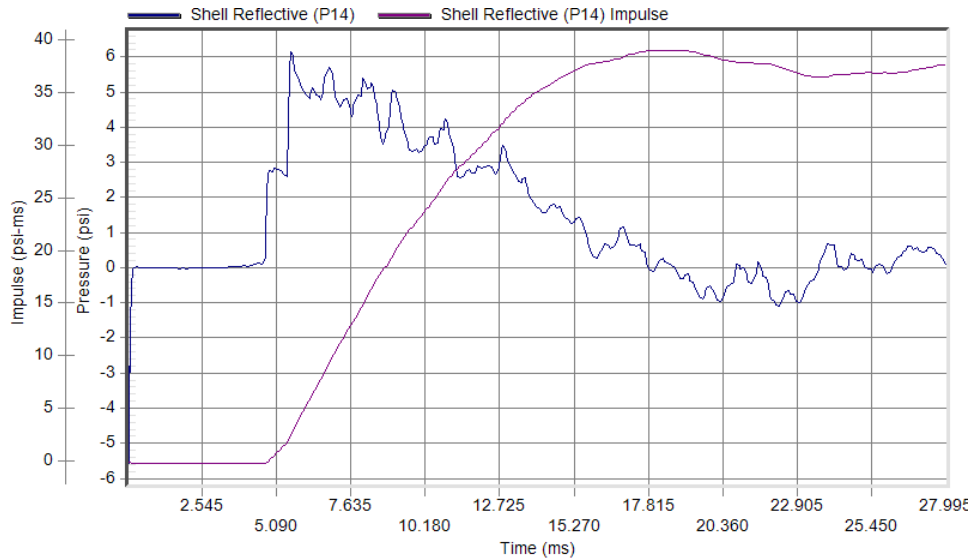
Test Specimen #2 - Pressure Time Plots

Peak Pressure: 6.19 psi at 5.62 ms
Duration: 12.17 ms

DESCRIPTION	RESULTS
Ambient Temperature	82°F
Glazing Temperature	85°F
ASTM Hazard Rating	Minimal Hazard
GSA Performance Condition	3a
PEAK POSITIVE PRESSURE	
Top Pressure	6.43 psi
Right Pressure	6.51 psi
Shell Pressure	6.19 psi
Average Pressure	6.38 psi
Witness Chamber Pressure	0.56 psi
PEAK POSITIVE PHASE DURATION	
Top Duration	9.80 msec
Right Duration	11.92 msec
Shell Duration	12.17 msec
Average Duration	11.30 msec
PEAK POSITIVE PHASE IMPULSE	
Top Impulse	39 psi*msec
Right Impulse	40 psi*msec
Shell Impulse	39 psi*msec
Average Impulse	39 psi*msec
GLAZING RESPONSE	
Exterior Lite	Fractured
Interior Lite	N/A
Glazing Pullout	None
Film Tearing	Film tore at bottom corner
WITNESS CHAMBER RESULTS	
Glass was deposited on the witness chamber floor. No damage observed to the witness panel.

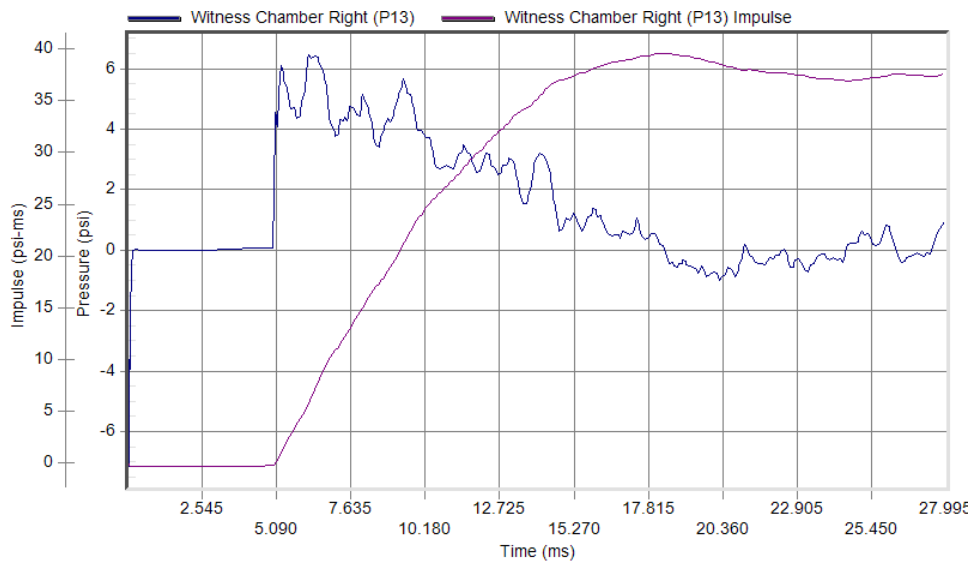
Peak Pressure: 6.51 psi at 6.43 ms
Duration: 11.92 ms

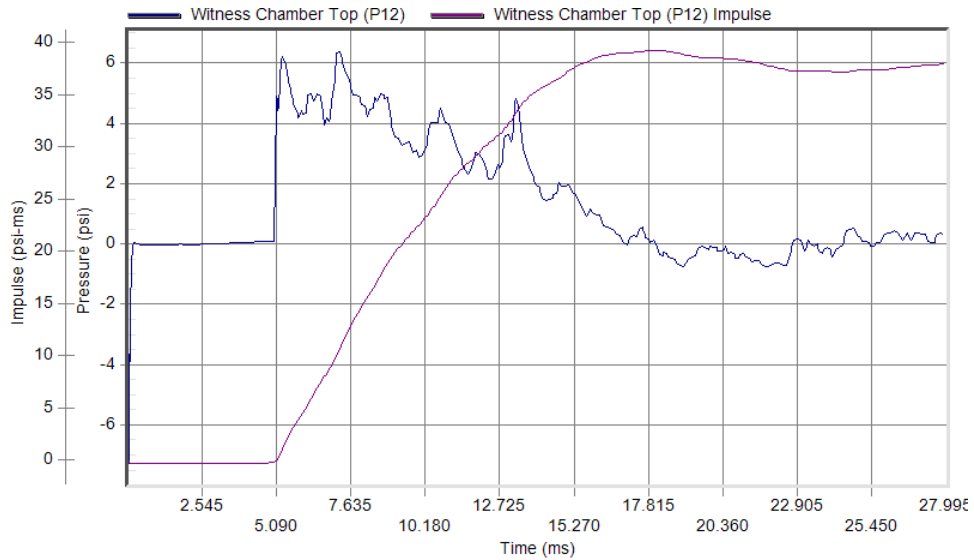
Test Specimen #2 - Pressure Time Plots (continued)

Peak Pressure: 6.43 psi at 7.18 ms
Duration: 9.80 ms

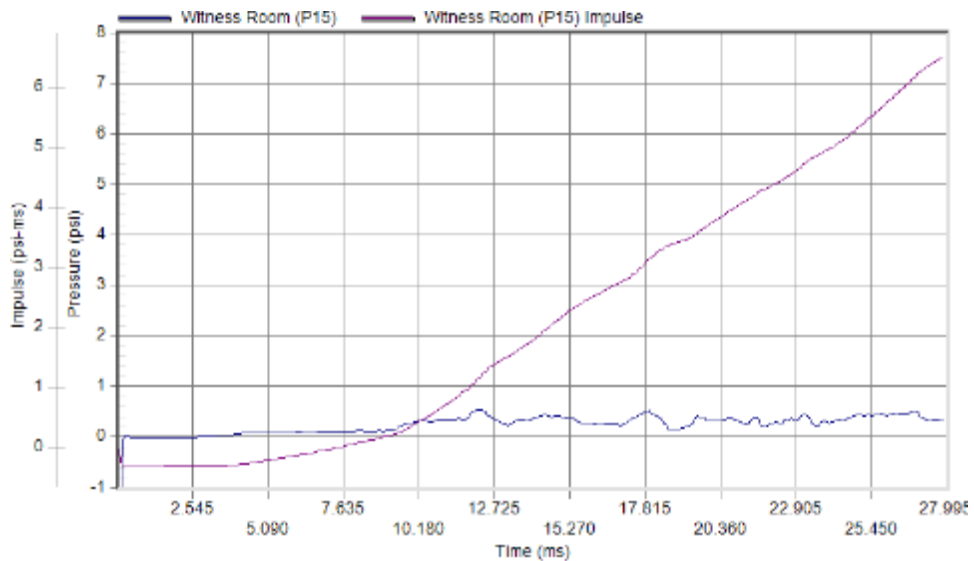
Peak Pressure: 0.56 psi at 12.21 ms
Duration: 0.00 ms

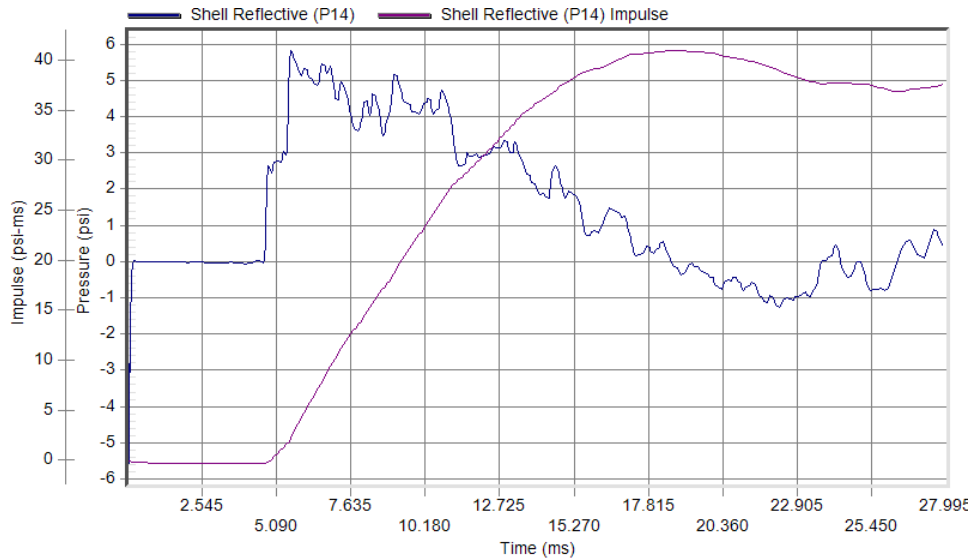
Test Specimen #3 - Pressure Time Plots

Peak Pressure: 5.83 psi at 5.62 ms
Duration: 12.96 ms

DESCRIPTION	RESULTS
Ambient Temperature	81°F
Glazing Temperature	82°F
ASTM Hazard Rating	Minimal Hazard
GSA Performance Condition	3a
PEAK POSITIVE PRESSURE	
Top Pressure	6.15 psi
Right Pressure	6.23 psi
Shell Pressure	5.83 psi
Average Pressure	6.07 psi
Witness Chamber Pressure	0.35 psi
PEAK POSITIVE PHASE DURATION	
Top Duration	12.55 msec
Right Duration	8.60 msec
Shell Duration	12.96 msec
Average Duration	11.37 msec
PEAK POSITIVE PHASE IMPULSE	
Top Impulse	41 psi*msec
Right Impulse	41 psi*msec
Shell Impulse	41 psi*msec
Average Impulse	41 psi*msec
GLAZING RESPONSE	
Exterior Lite	Fractured
Interior Lite	N/A
Glazing Pullout	None
Film Tearing	None
WITNESS CHAMBER RESULTS	
Glass was deposited on the witness chamber floor. One small fragment located within the 1M mark. No damage observed to the witness panel.

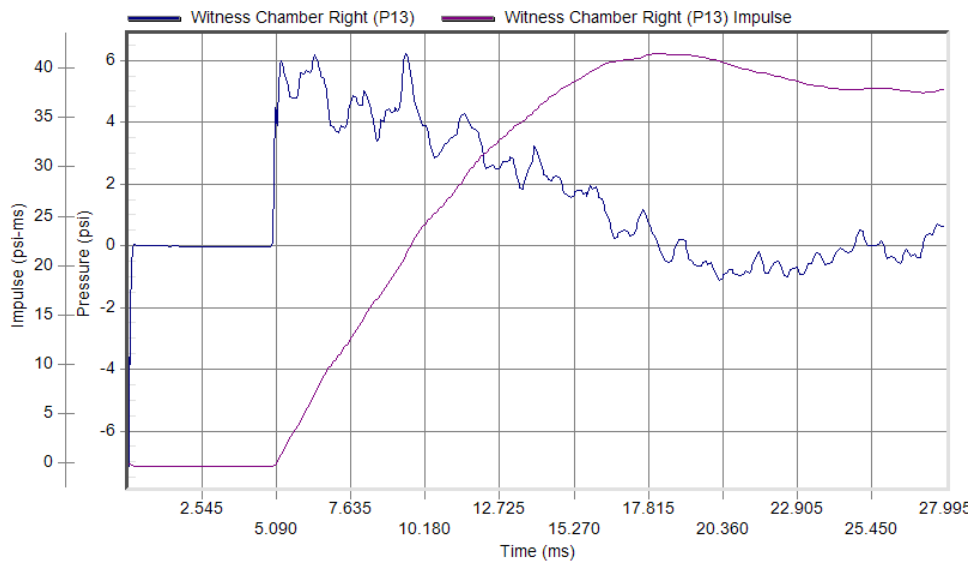
Peak Pressure: 6.23 psi at 9.55 ms
Duration: 8.60 ms

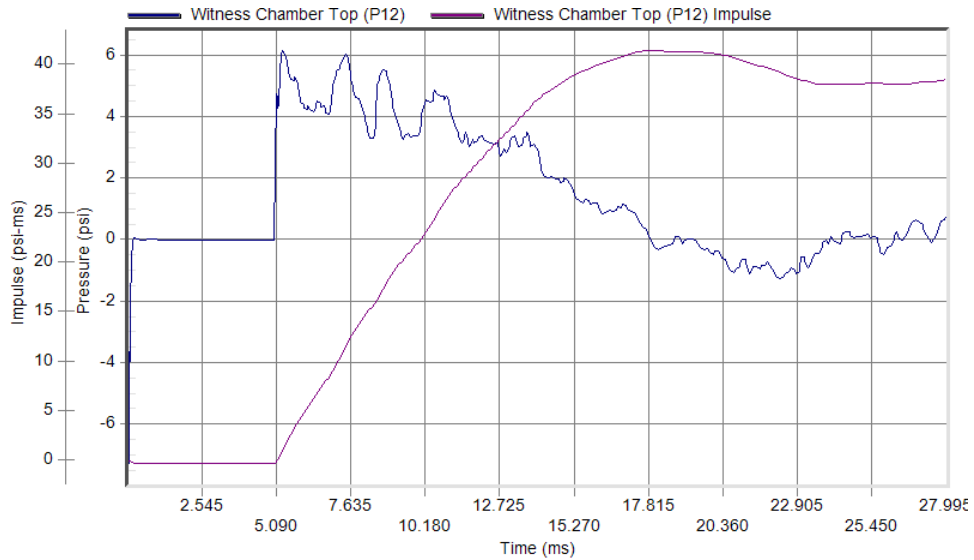
Test Specimen #3 - Pressure Time Plots (continued)

Peak Pressure: 6.15 psi at 5.32 ms
Duration: 12.55 ms

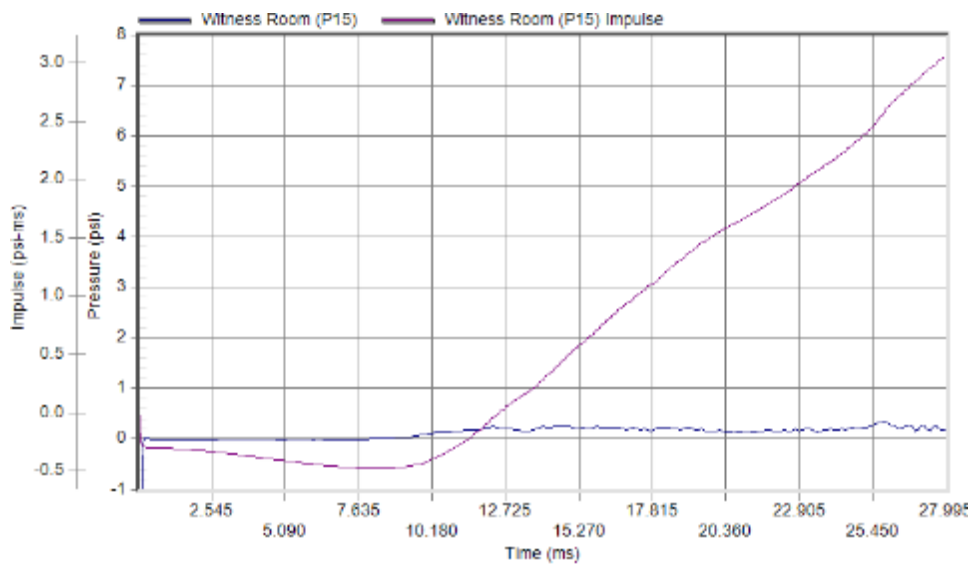
Peak Pressure: 0.35 psi at 25.82 ms
Duration: 0.00 ms

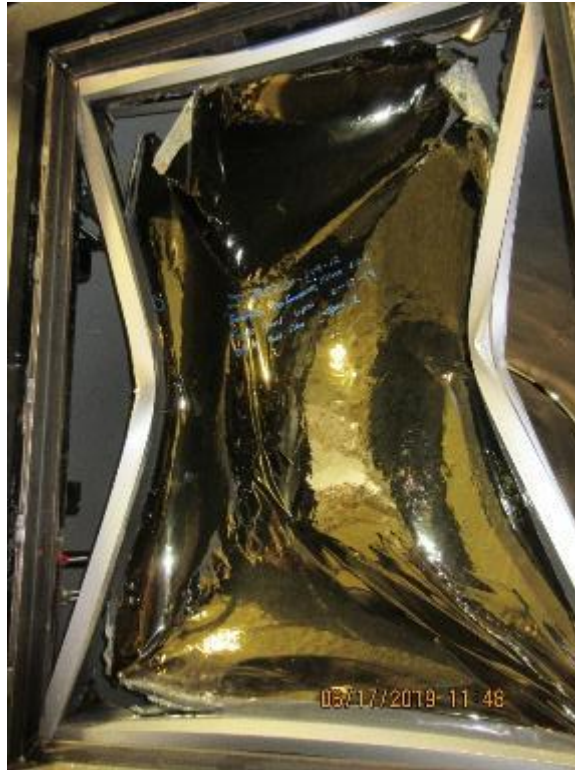
Photo No. 2
Post-test Specimen #1, Interior

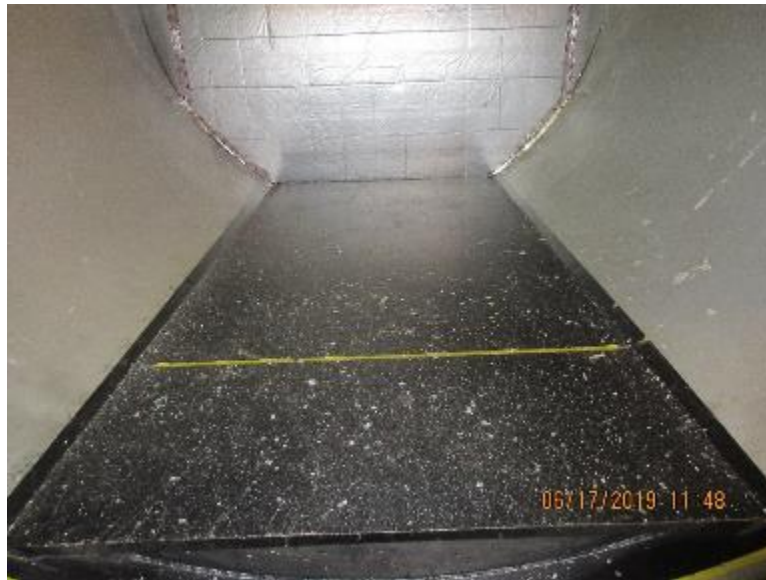
Photo No. 3
Post-test Specimen #1, Witness Chamber

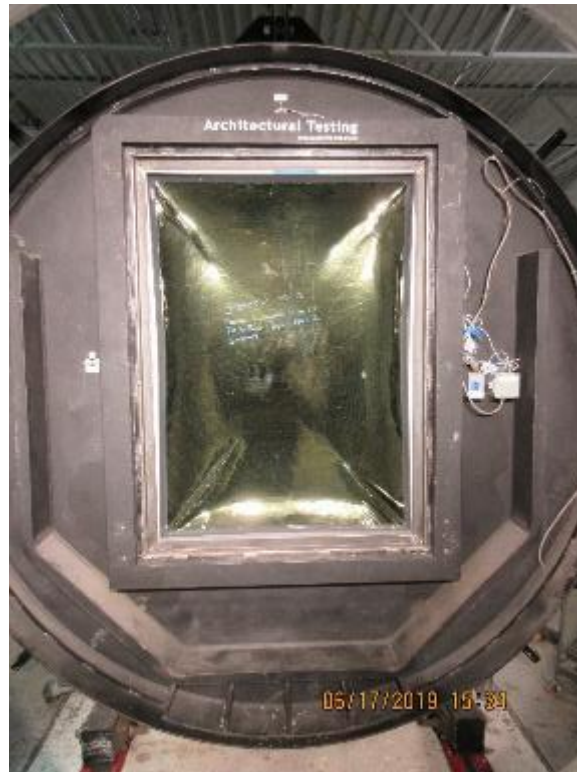
Photo No. 5
Post-test Specimen #2, Interior

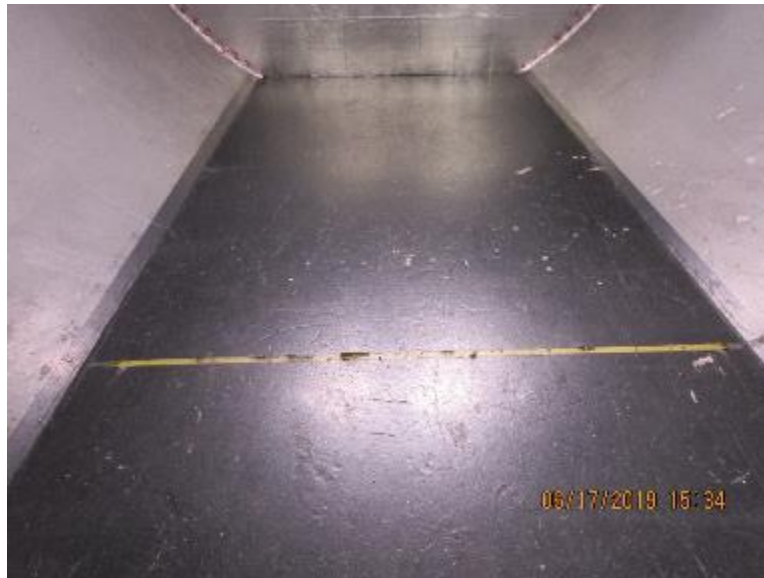
Photo No. 6
Post-test Specimen #2, Witness Chamber

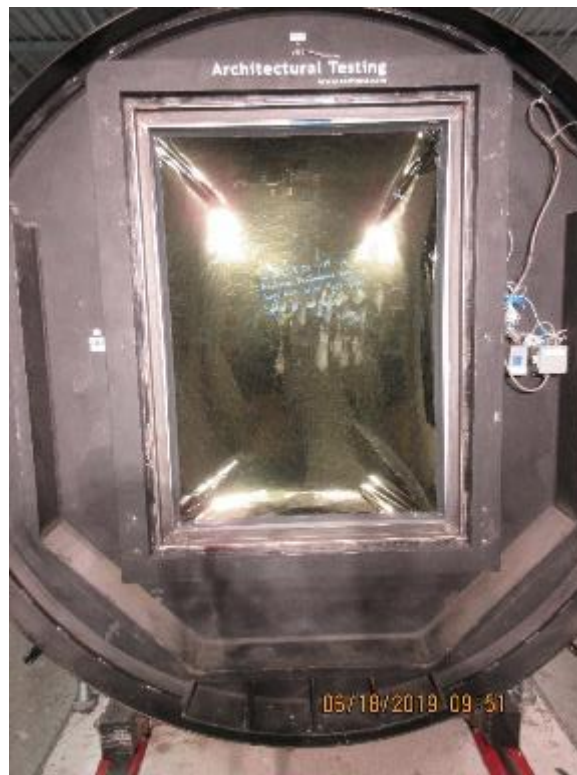
Photo No. 8
Post-test Specimen #3, Interior

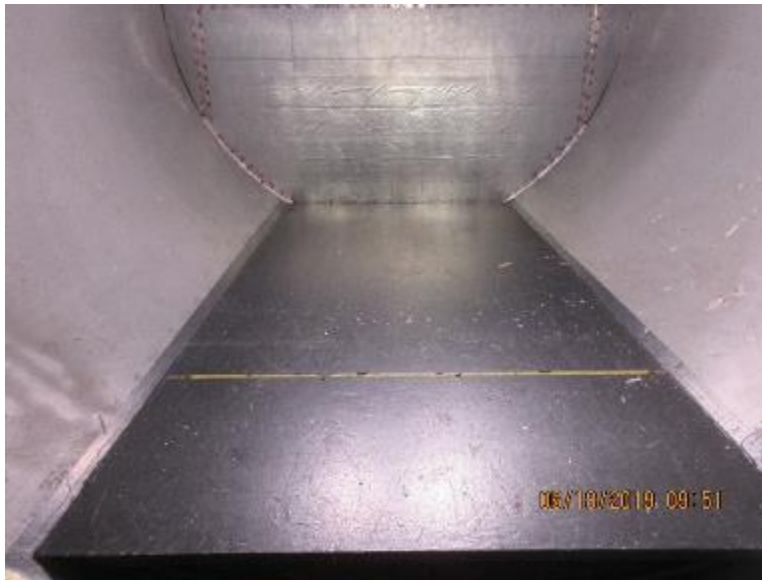
Photo No. 9
Post-test Specimen #3, Witness Chamber

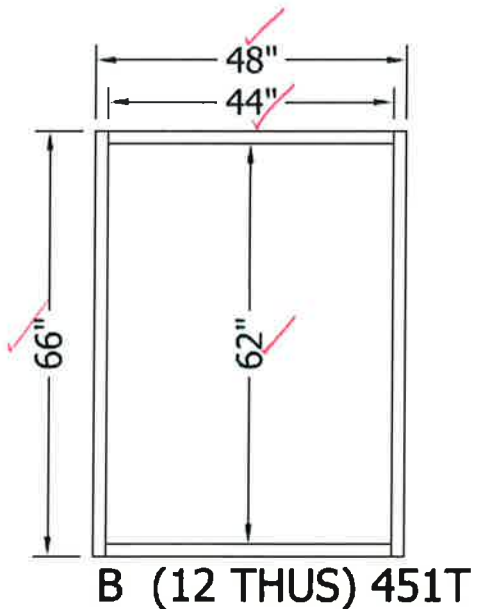
Dual-pane unit frames

Kawneer 451 Aluminum Framing

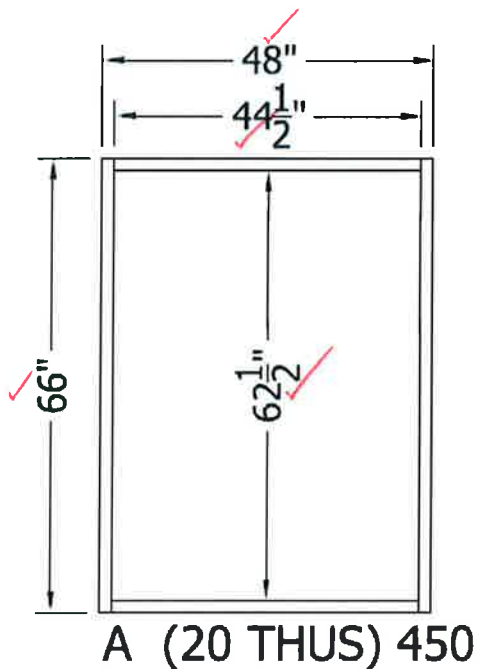
Single-pane unit frames

Kawneer 450 Aluminum Framing

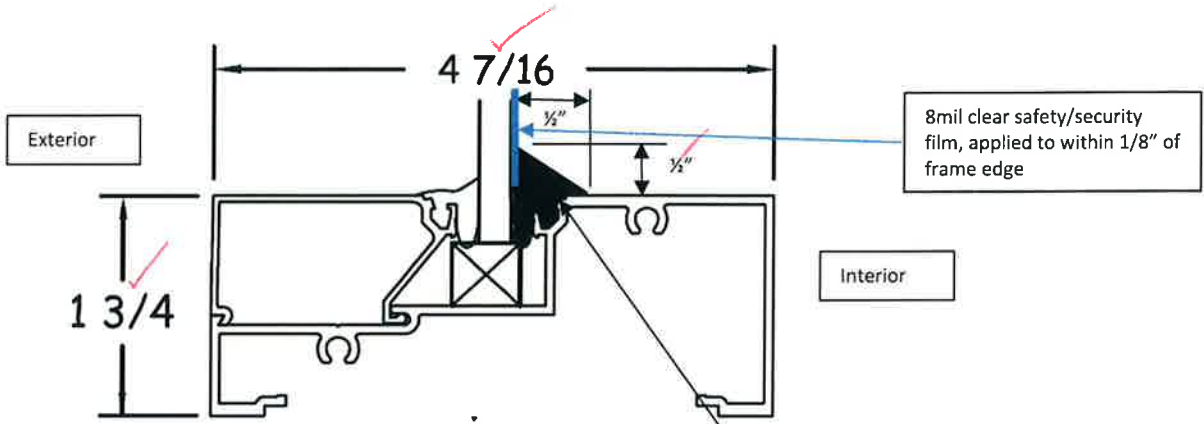
SILL
DETAIL F9

Tremco Proglaze SSG or Dow Corning 995 Structural Silicone Caulking, 3/4" onto film, 3/4" onto frame and into framing groove where rubber gasket has been removed. Bead width 1".

Silicone bead applied on all four sides to interior of window.

Glazing Method: The glass was channel glazed from the exterior and was secured in place with snap-fit extruded aluminum glazing stop at the sill and a flexible rubber gasket around the glazing perimeter. A 9 mil thick safety and security film was adhered to the interior lite and a bead of silicone was applied around the perimeter of the frame at the glazing edge.

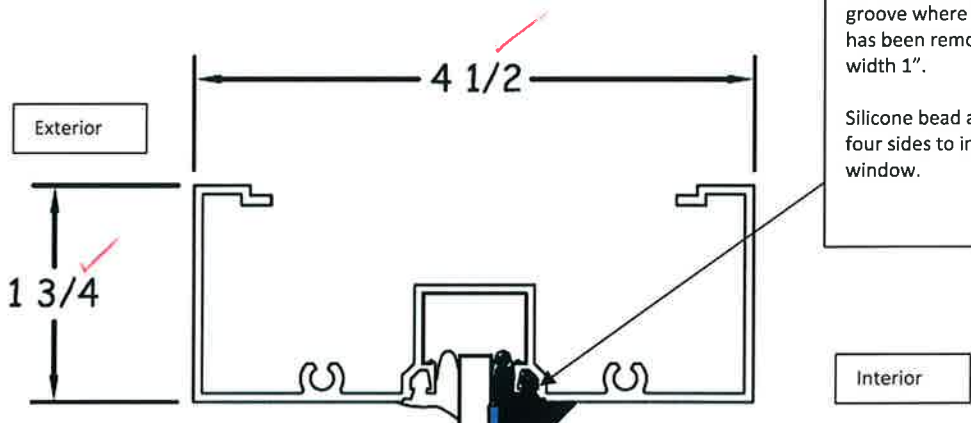
HEAD
DETAIL F12

Glass:
single-pane or dual-pane
(single-pane shown)
