AIRBLAST LOADING TEST REPORT

ASTM F1642/GSA TS01 TESTING ON DR25 SR PS9 SAFETY AND SECURITY PERFORMANCE FILM
INSTALLED ON A FIXED WINDOW SYSTEM
(DUAL PANE, ANNEALED, SILICONE GLAZING ATTACHMENT)

J3983.09-119-12 R0

TEST REPORT FOR EASTMAN PERFORMANCE FILMS, LLC

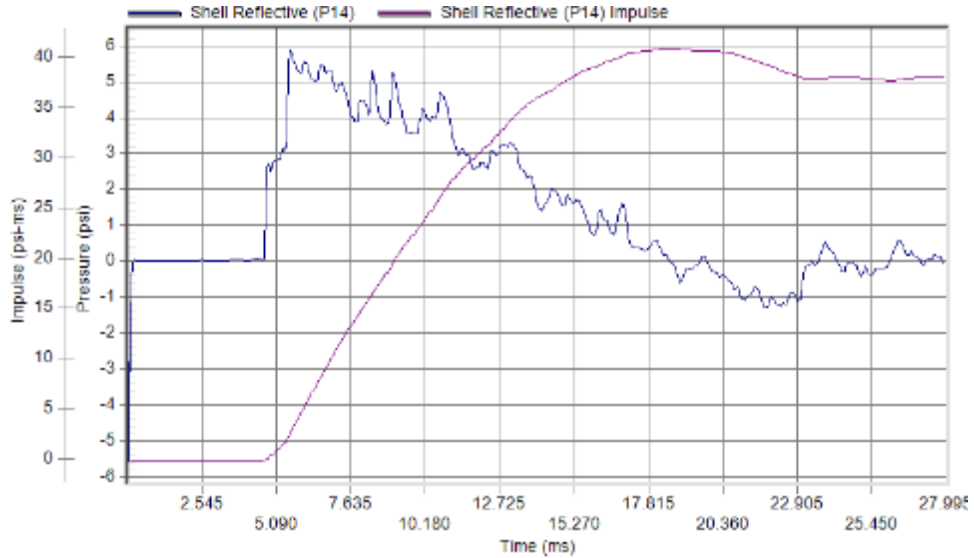
Test Specimen #1 - Pressure Time Plots

Peak Pressure: 5.93 psi at 5.57 ms
Duration: 12.94 ms

DESCRIPTION	RESULTS
Ambient Temperature	85°F
Glazing Temperature	85°F
ASTM Hazard Rating	No Hazard
GSA Performance Condition	2
PEAK POSITIVE PRESSURE	
Top Pressure	6.45 psi
Right Pressure	6.27 psi
Shell Pressure	5.93 psi
Average Pressure	6.22 psi
Witness Chamber Pressure	0.24 psi
PEAK POSITIVE PHASE DURATION	
Top Duration	12.76 msec
Right Duration	11.97 msec
Shell Duration	12.94 msec
Average Duration	12.56 msec
PEAK POSITIVE PHASE IMPULSE	
Top Impulse	42 psi*msec
Right Impulse	42 psi*msec
Shell Impulse	41 psi*msec
Average Impulse	42 psi*msec
GLAZING RESPONSE	
Exterior Lite	Fractured
Interior Lite	Unbroken
Glazing Pullout	None
Film Tearing	None
WITNESS CHAMBER RESULTS	
A dusting of glass was deposited on the witness chamber floor.

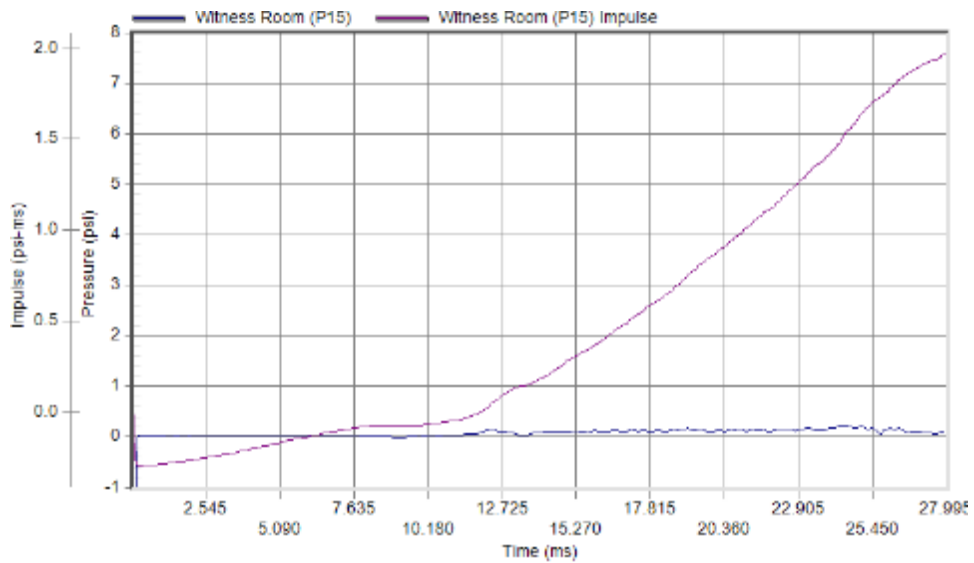
Peak Pressure: 0.24 psi at 25.06 ms
Duration: 2.56 ms

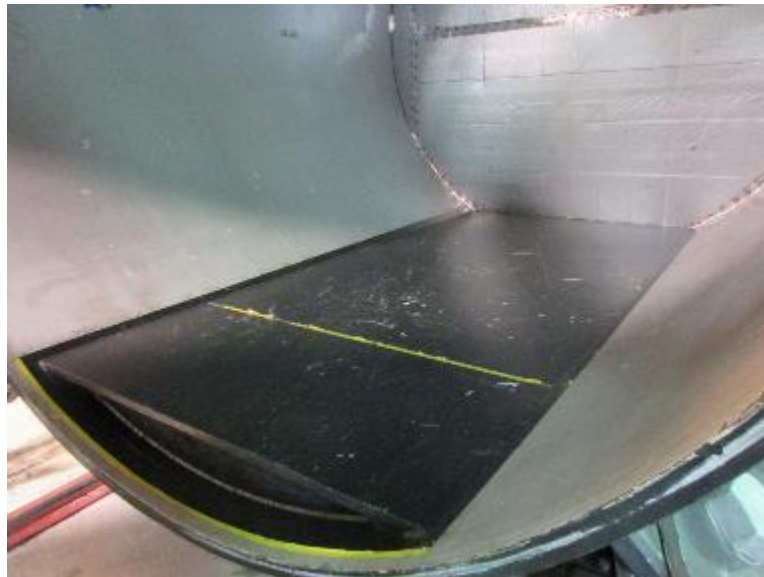
Photo No. 3
Post-test Specimen #1, Witness Chamber

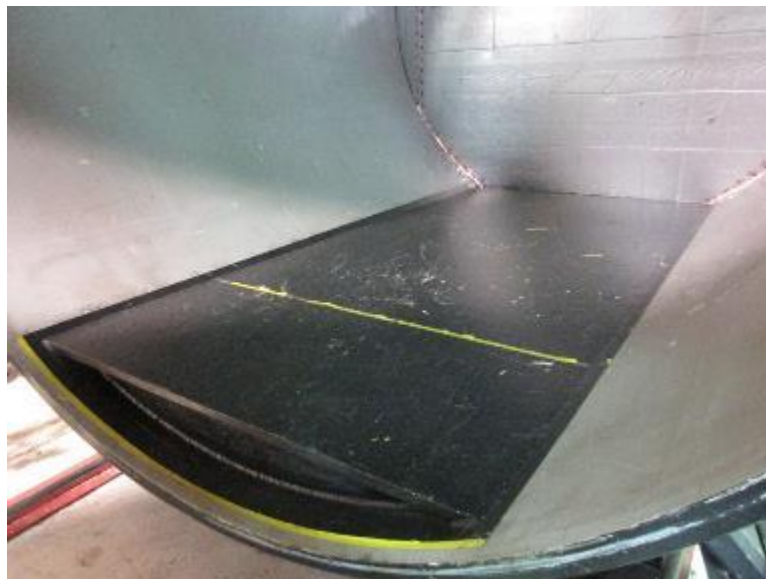
Photo No. 9
Post-test Specimen #3, Witness Chamber

DESCRIPTION	RESULTS
Ambient Temperature	88°F
Glazing Temperature	89°F
ASTM Hazard Rating	No Hazard
GSA Performance Condition	2
PEAK POSITIVE PRESSURE	
Top Pressure	6.18 psi
Right Pressure	6.48 psi
Shell Pressure	6.27 psi
Average Pressure	6.31 psi
Witness Chamber Pressure	0.16 psi
PEAK POSITIVE PHASE DURATION	
Top Duration	12.67 msec
Right Duration	11.99 msec
Shell Duration	12.95 msec
Average Duration	12.54 msec
PEAK POSITIVE PHASE IMPULSE	
Top Impulse	41 psi*msec
Right Impulse	42 psi*msec
Shell Impulse	41 psi*msec
Average Impulse	41 psi*msec
GLAZING RESPONSE	
Exterior Lite	Fractured
Interior Lite	Unbroken
Glazing Pullout	None
Film Tearing	None
WITNESS CHAMBER RESULTS	
A dusting of glass was deposited on the witness chamber floor.
